**Critical Review of the Life Span of
TPO and PVC
RCI Hawaii Seminar
January 20-21, 2010**

**Karim P. Allana, P.E., RRC, RWC
Allana Buick & Bers, Inc.**

Case Study: PVC

Case Study: TPO

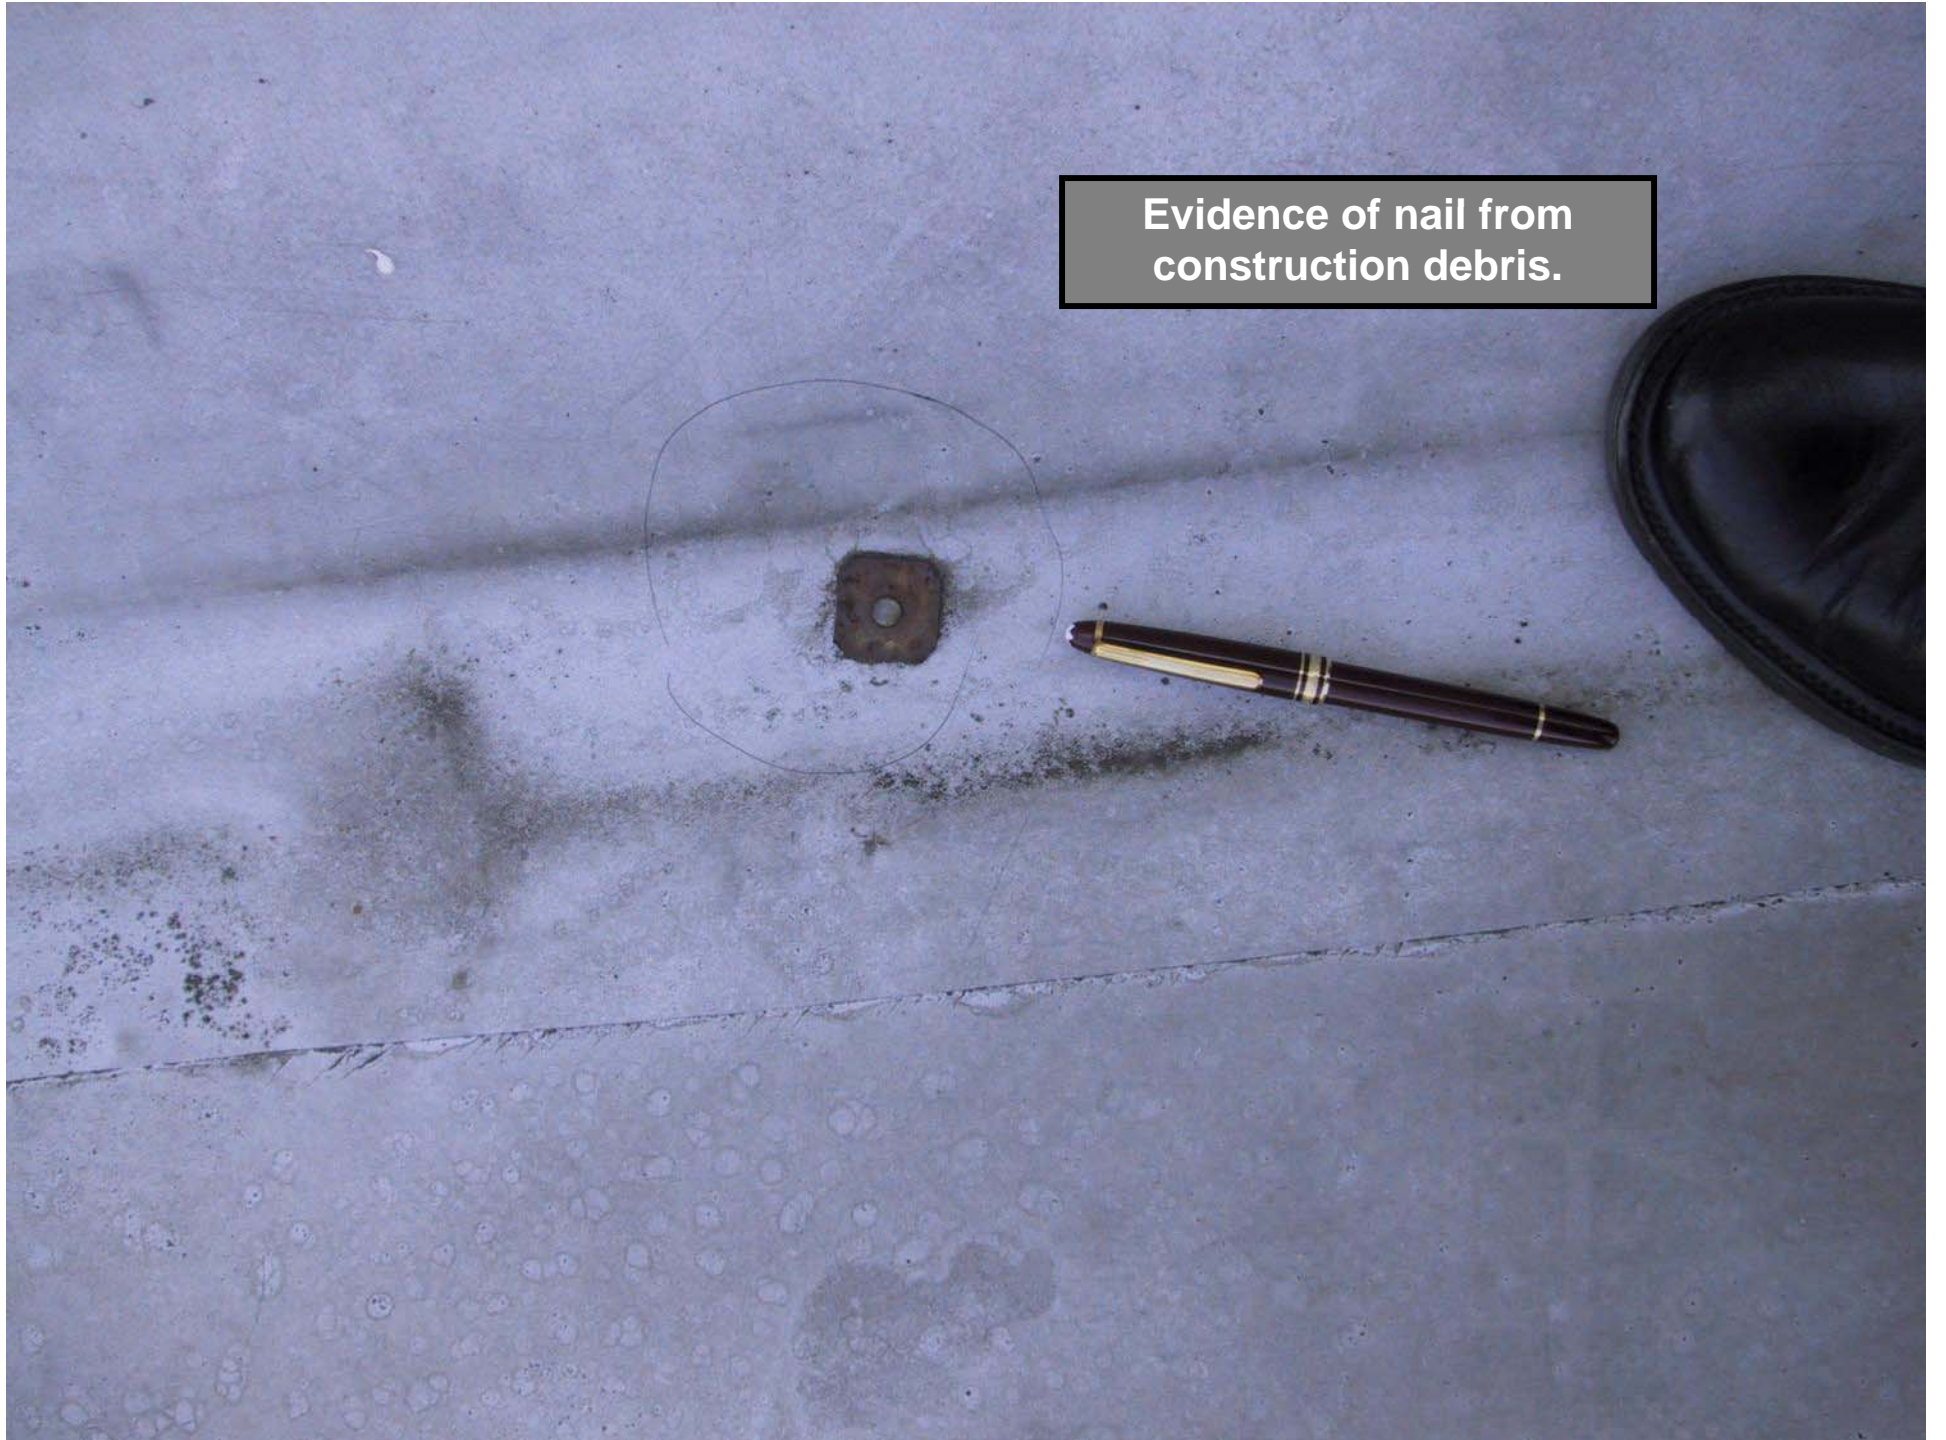
Impact damage from unknown source.

Evidence of nail from
construction debris.

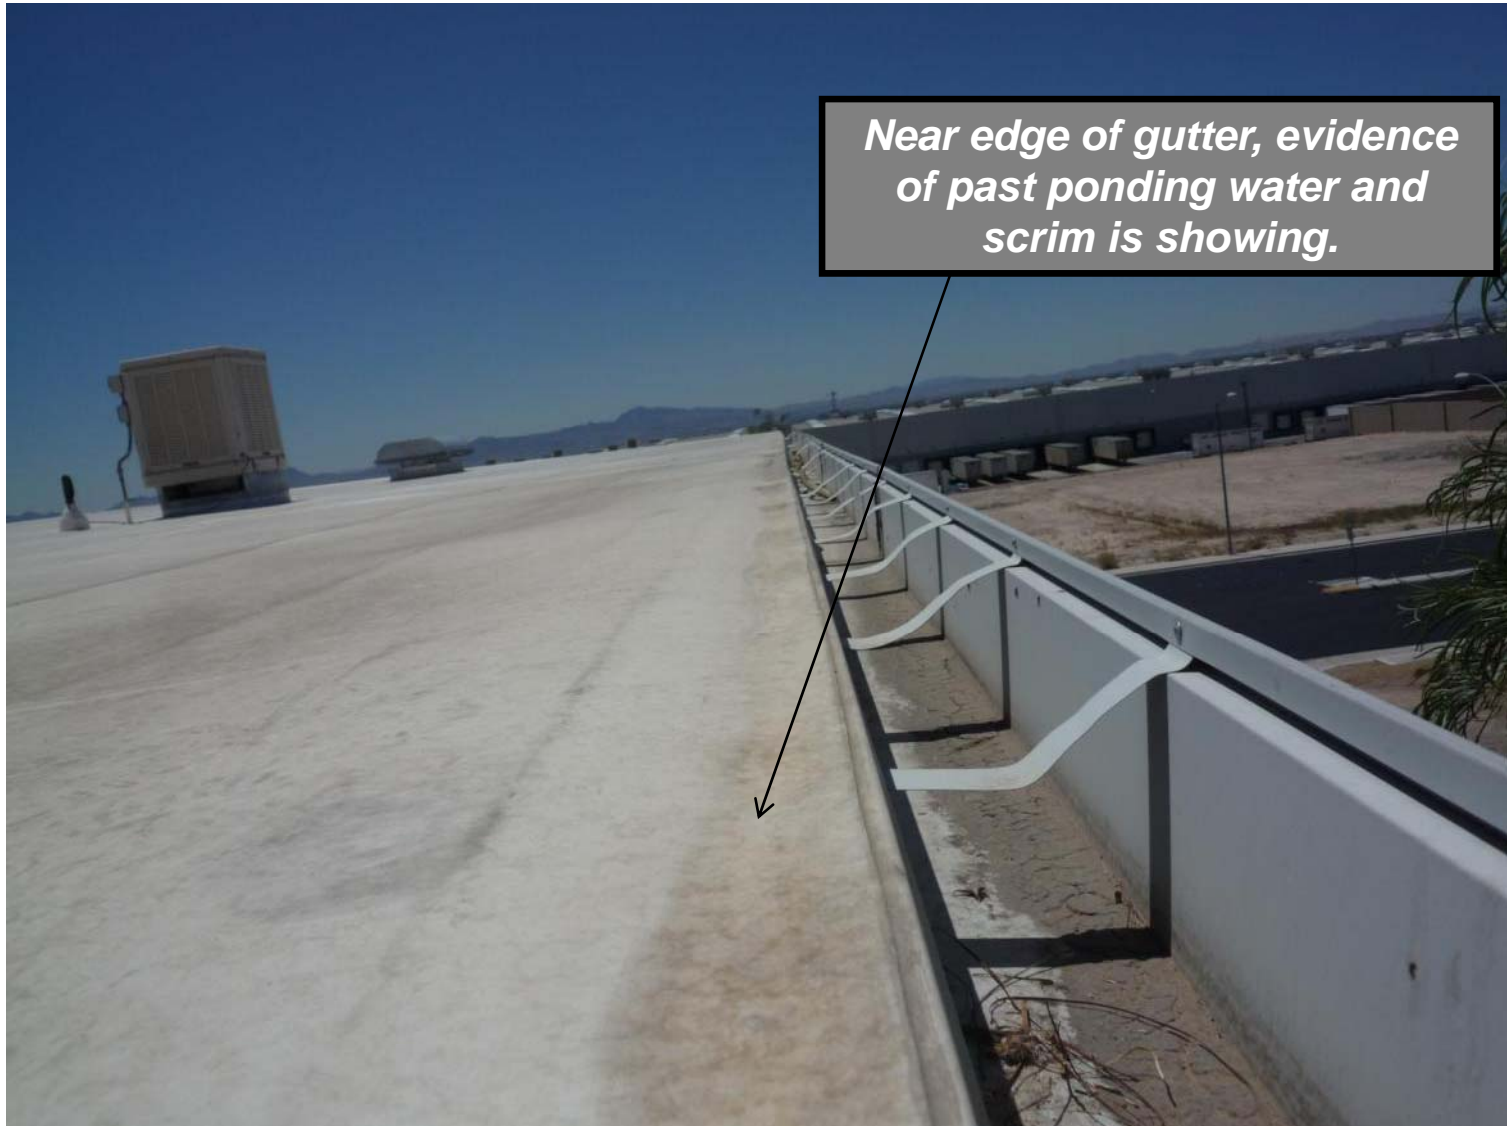
Near edge of gutter, evidence of past ponding water and scrim is showing.

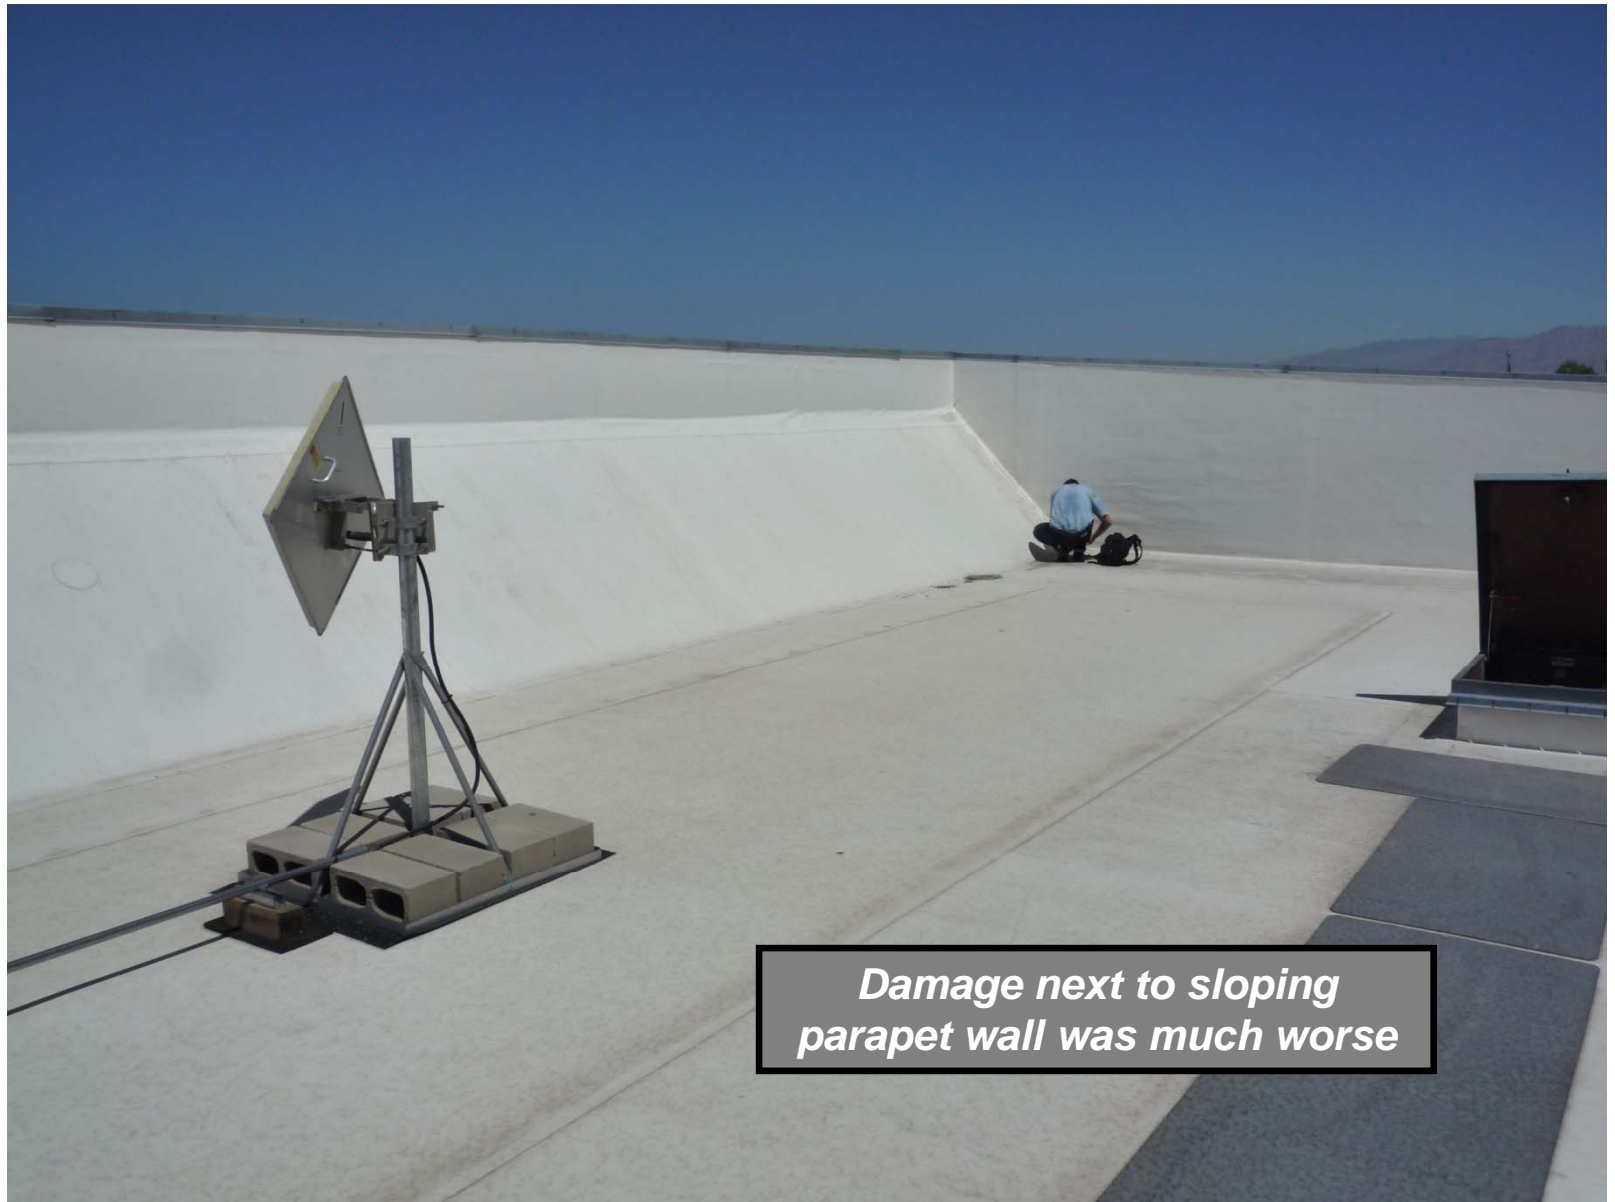
*Damage next to sloping
parapet wall was much worse*

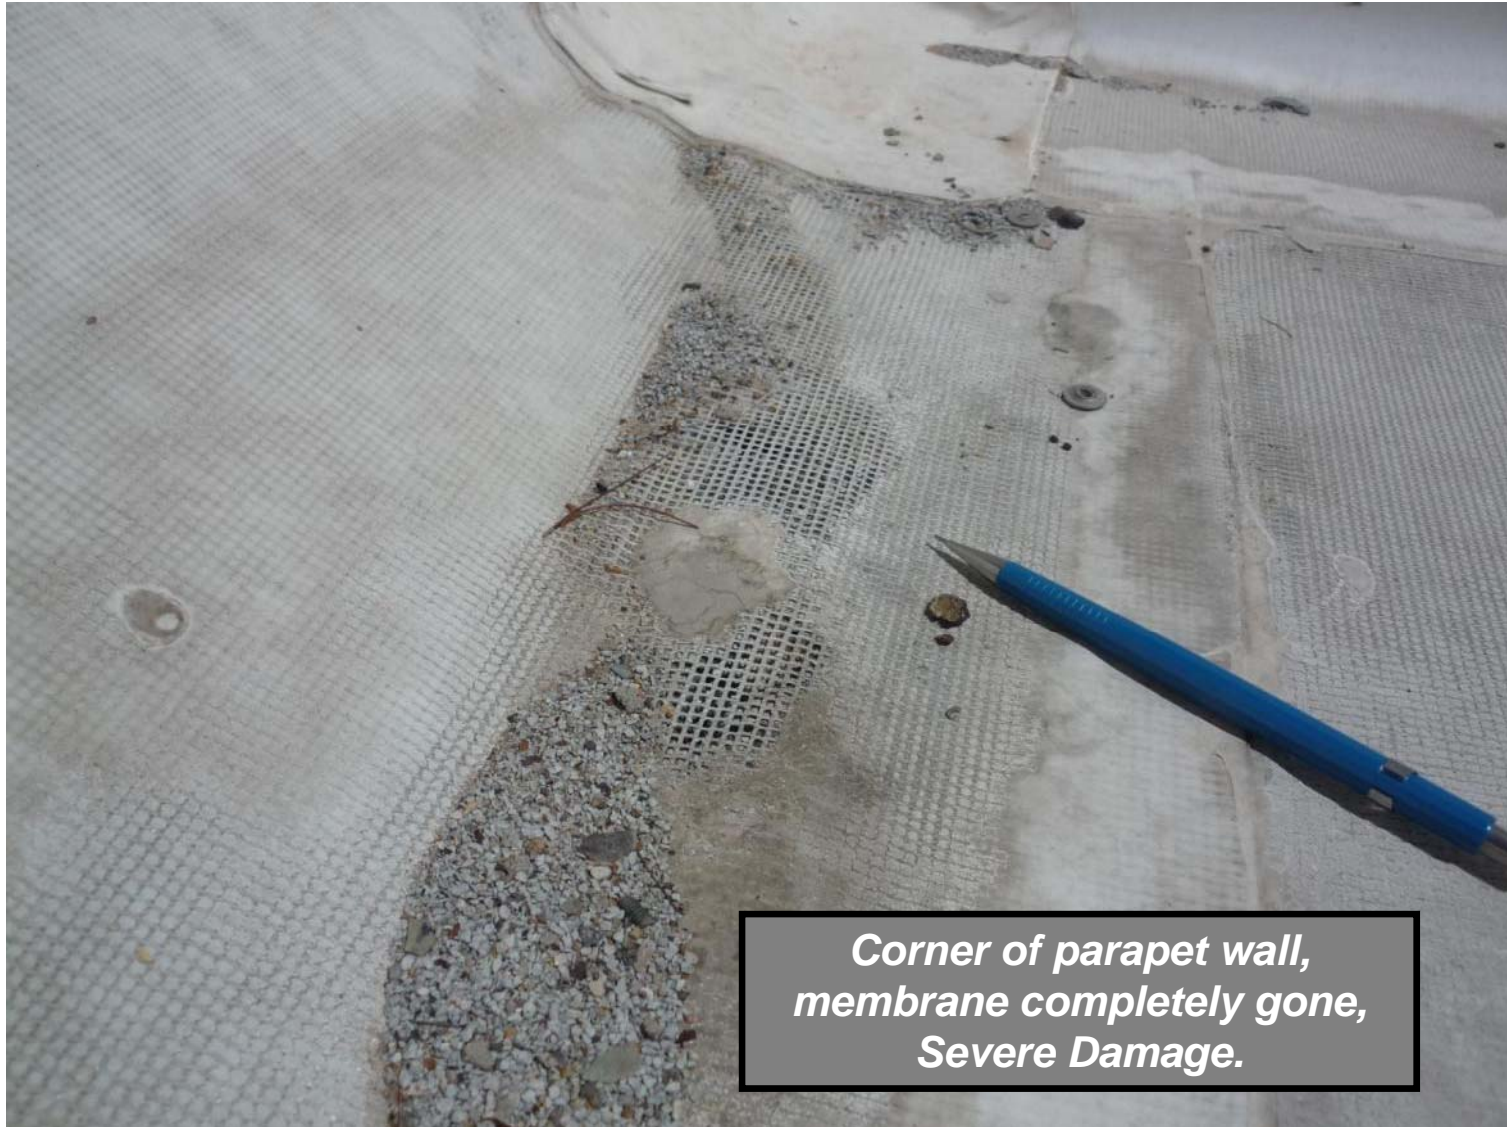
*Corner of parapet wall,
membrane completely gone,
Severe Damage.*

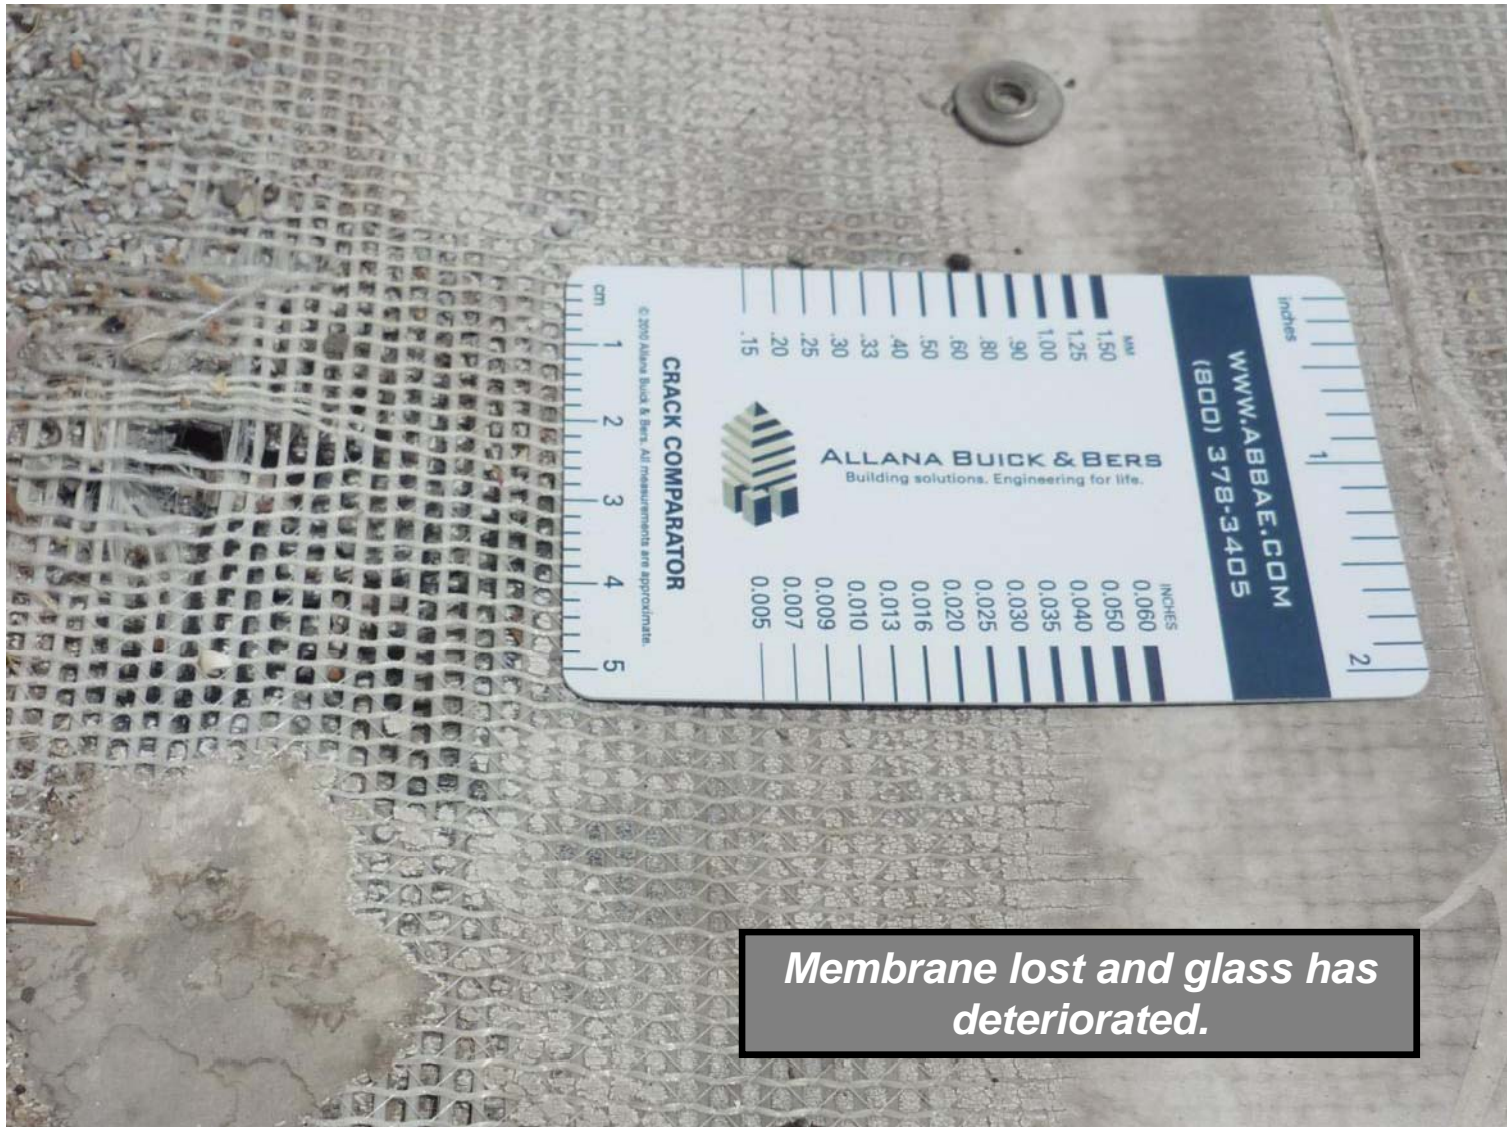
Membrane lost and glass has deteriorated.

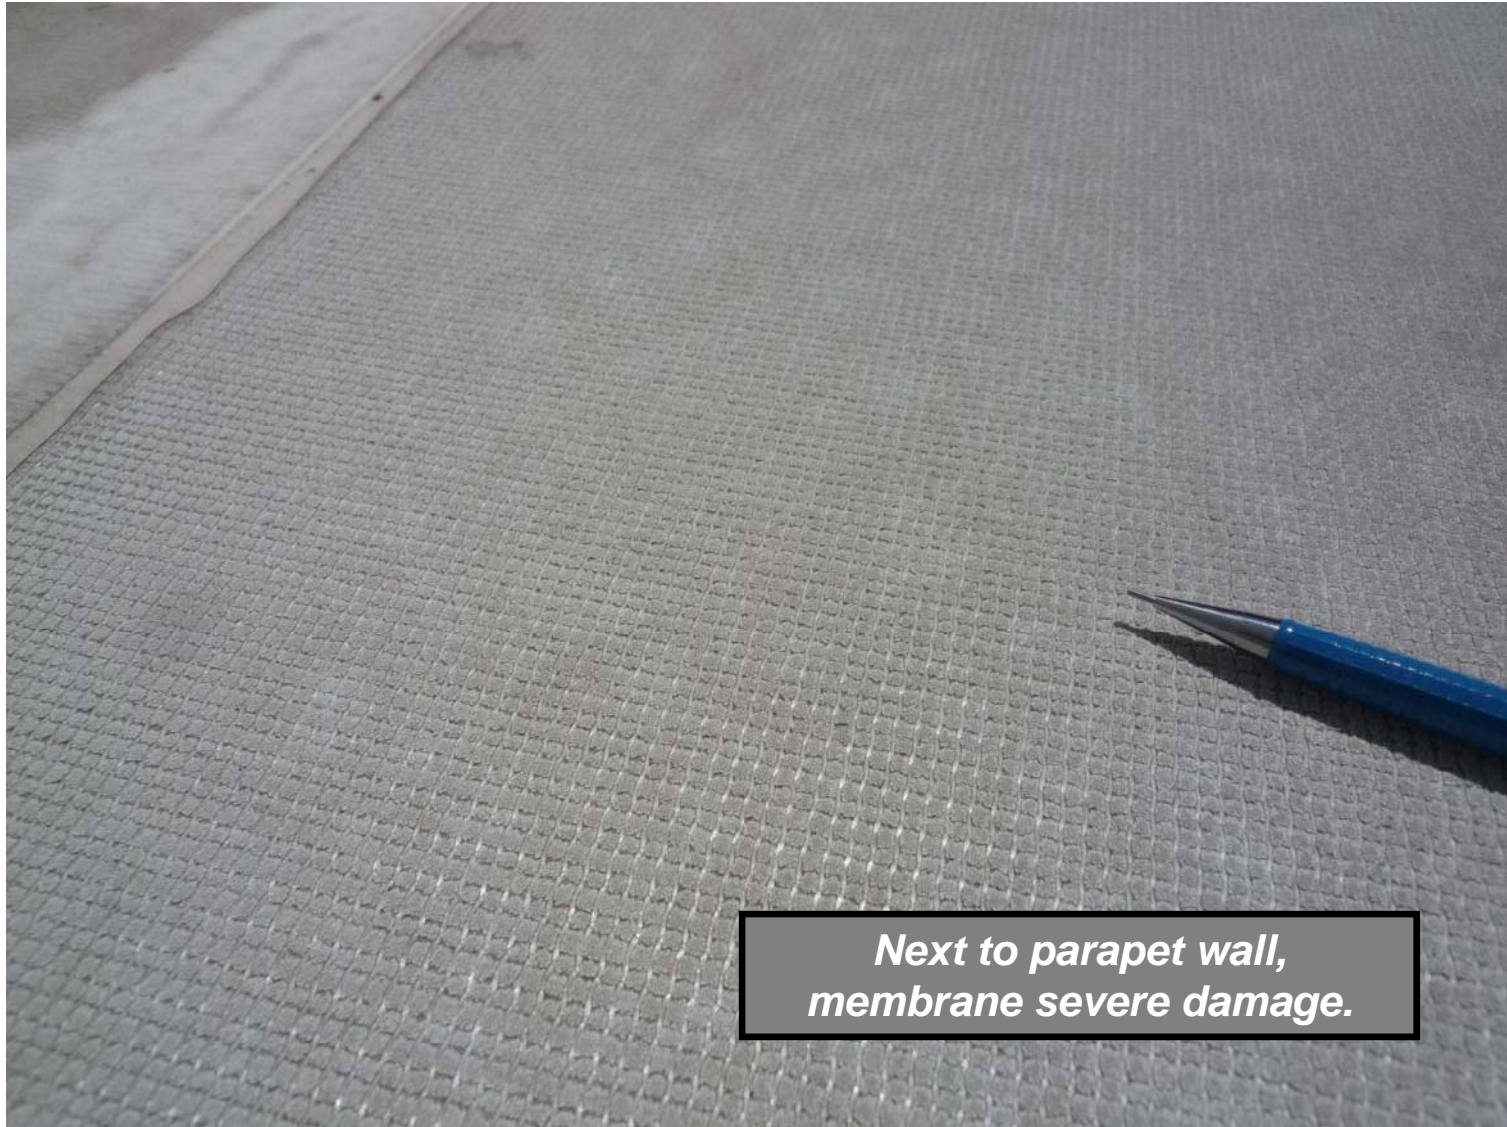
*Next to parapet wall,
membrane severe damage.*

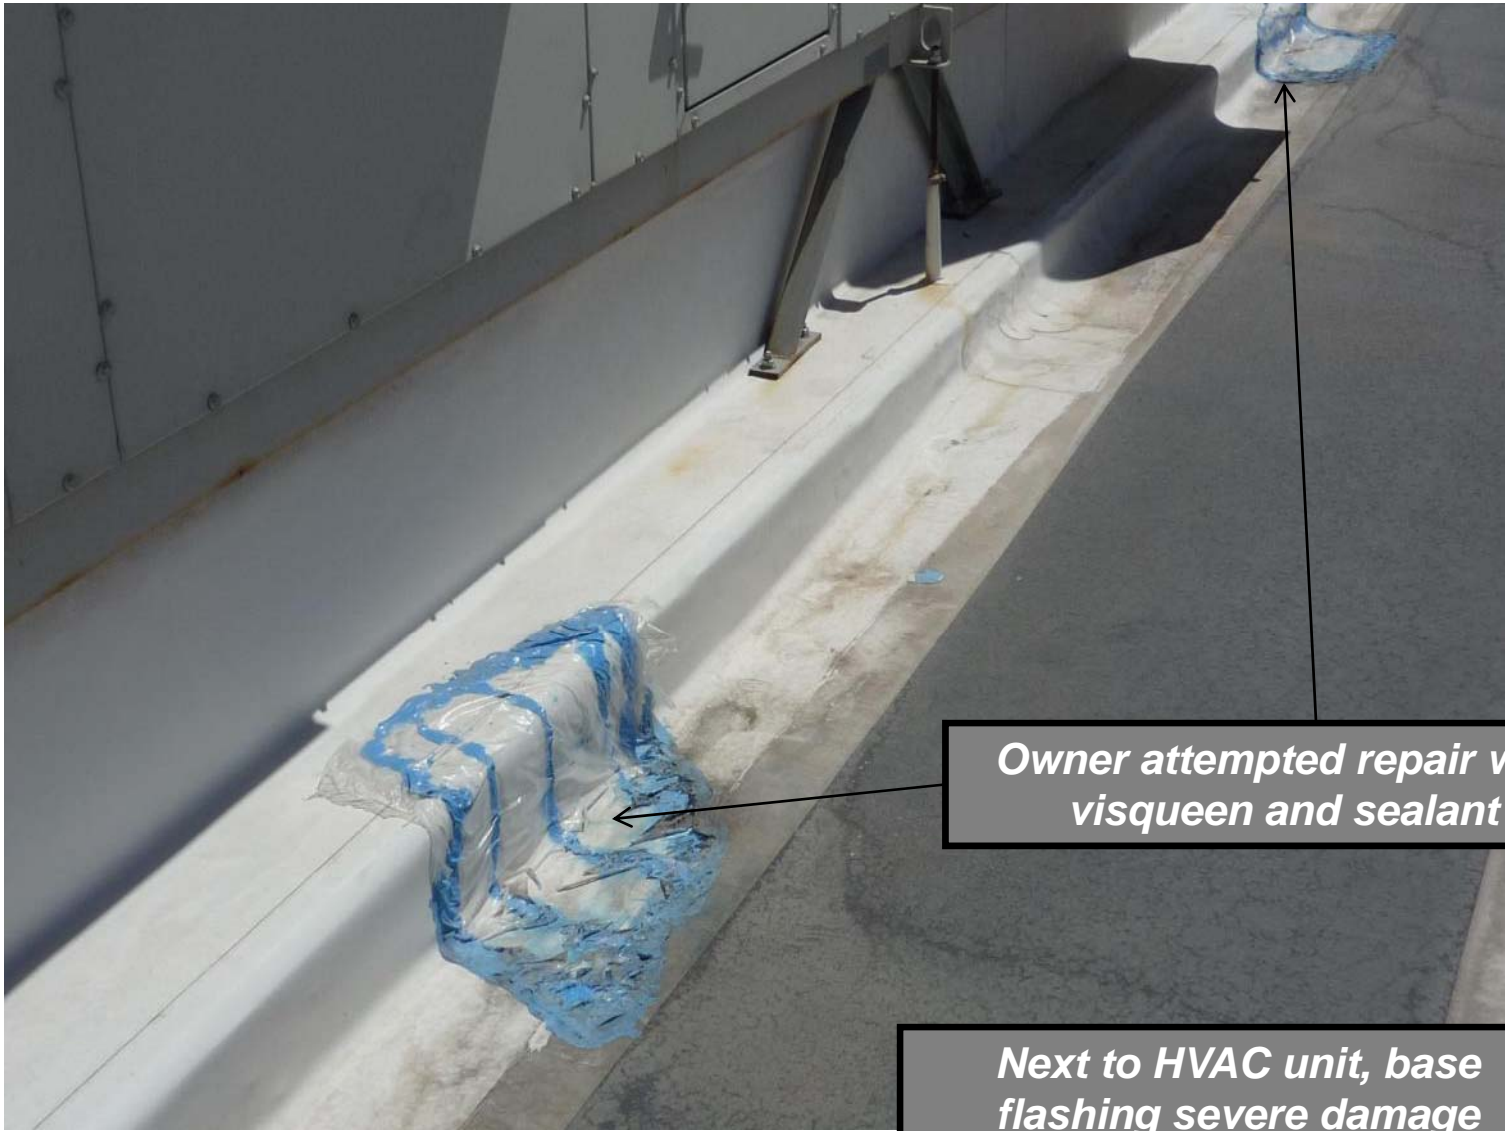
Owner attempted repair with visqueen and sealant

Next to HVAC unit, base flashing severe damage

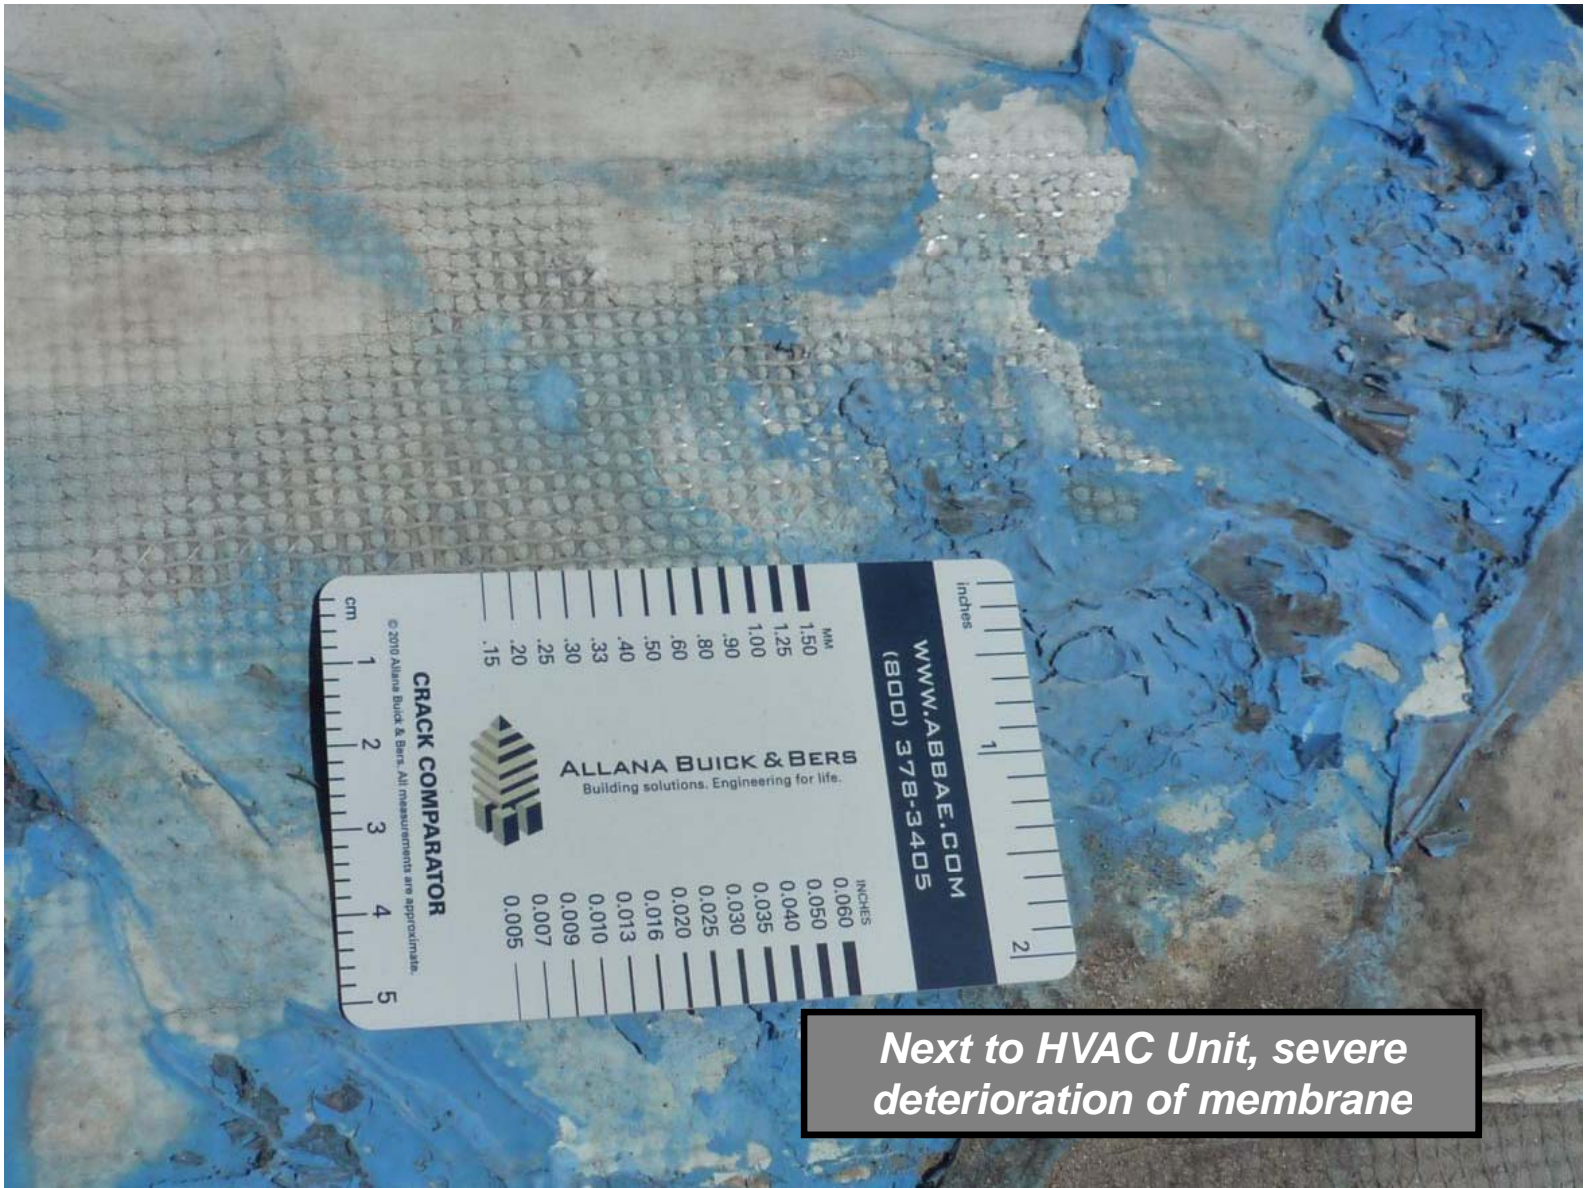
Next to HVAC Unit, severe deterioration of membrane

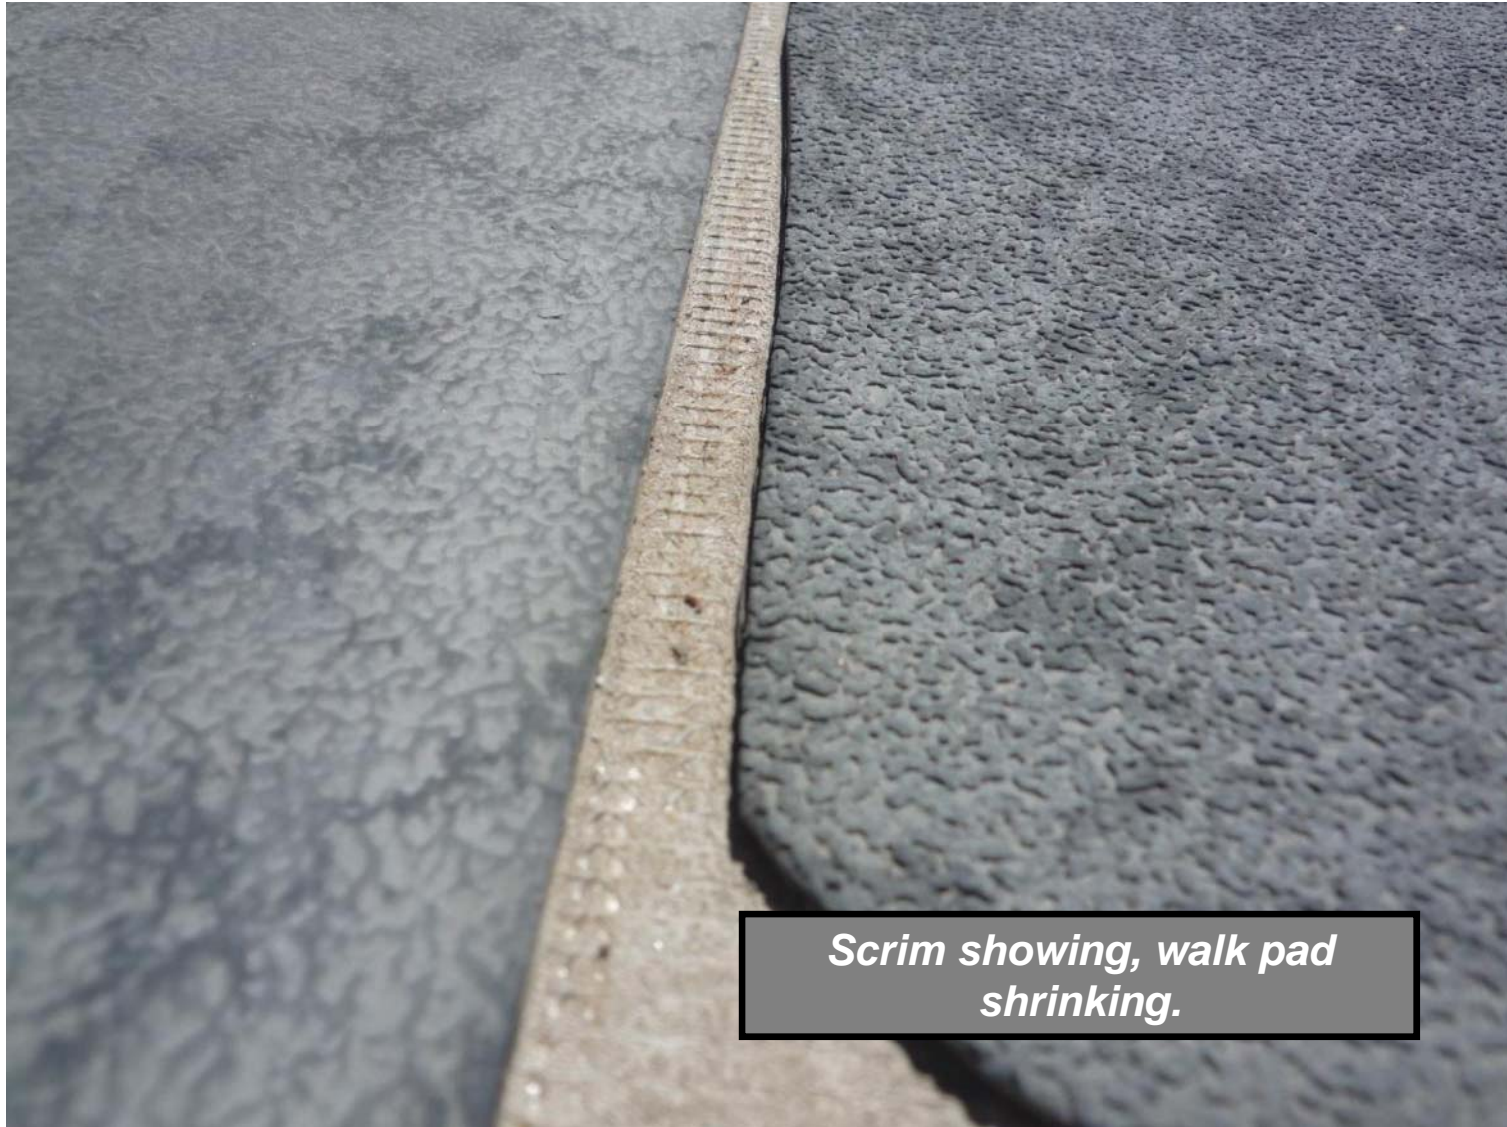
Scrim showing, walk pad shrinking.

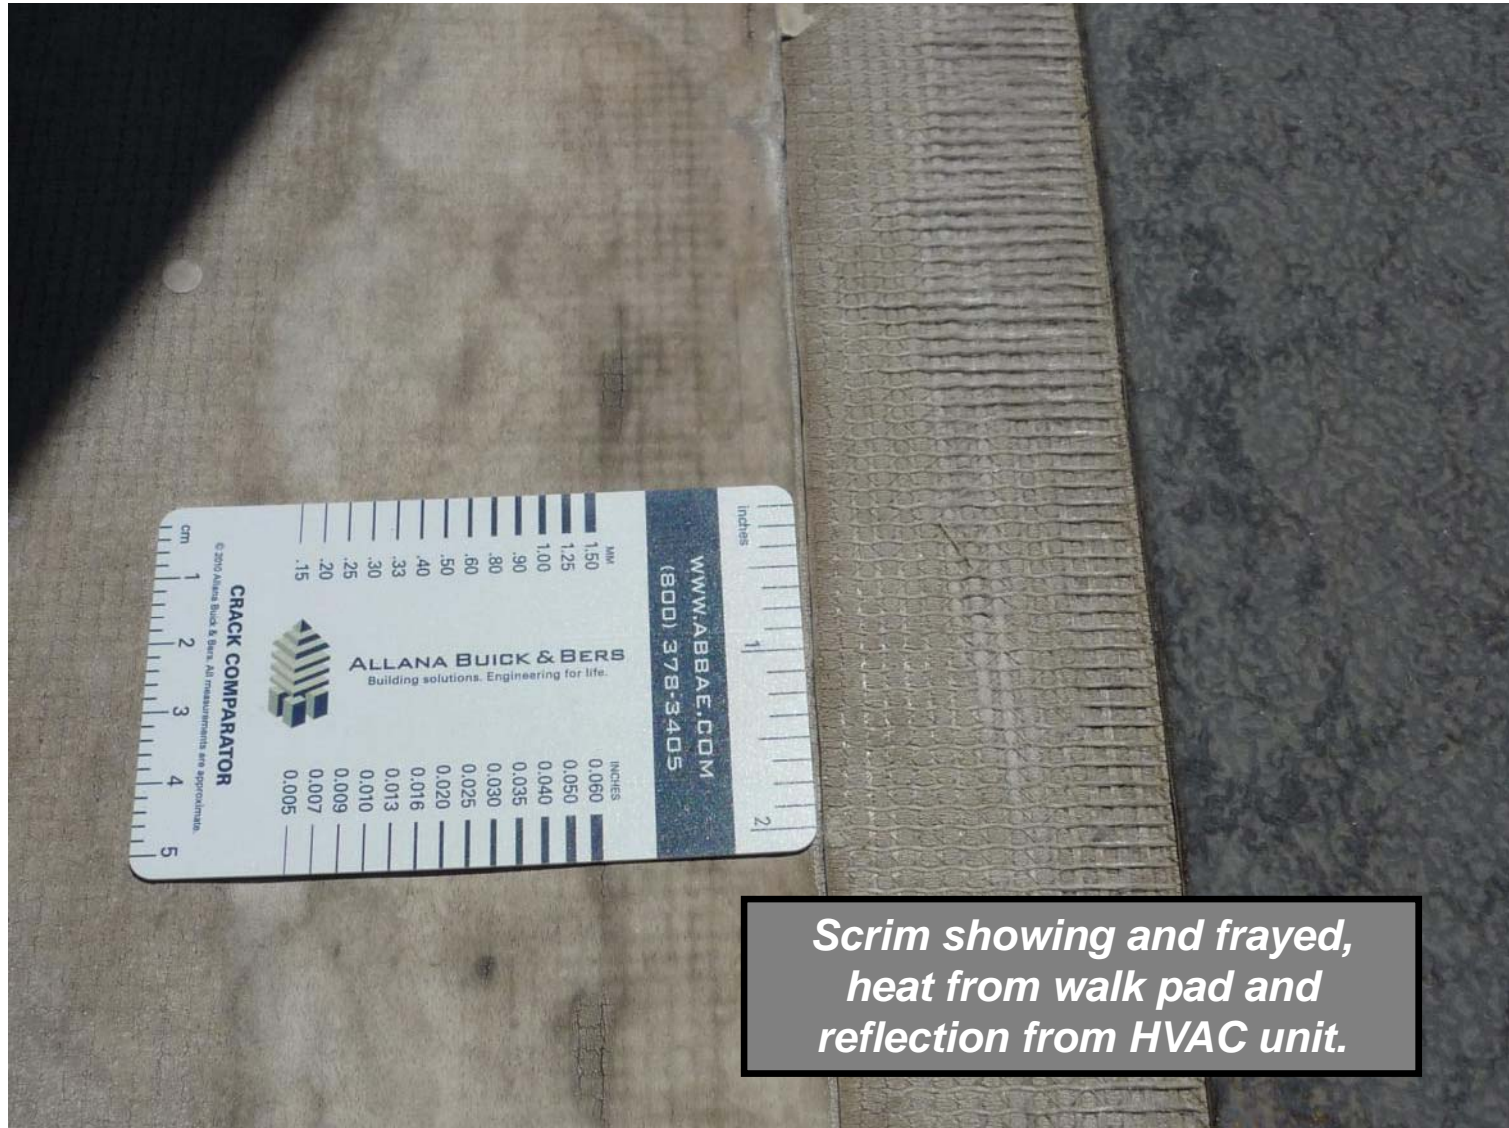
*Scrim showing and frayed,
heat from walk pad and
reflection from HVAC unit.*

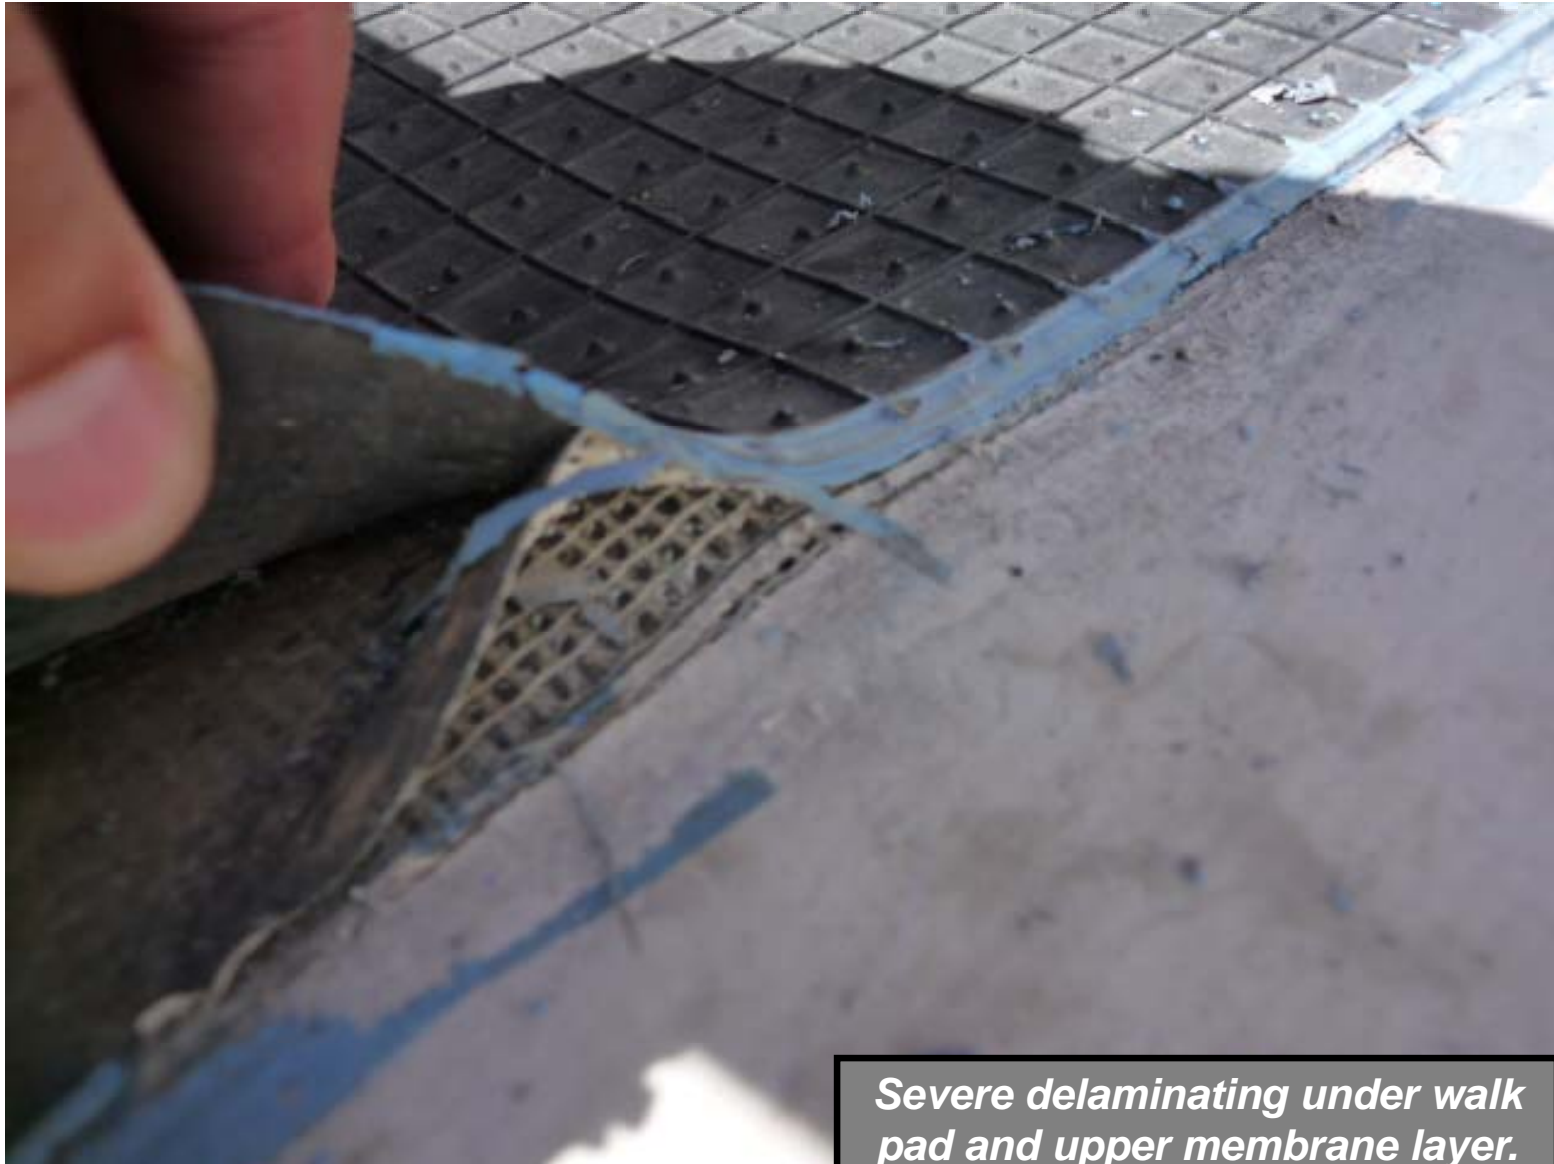
Severe delaminating under walk pad and upper membrane layer.

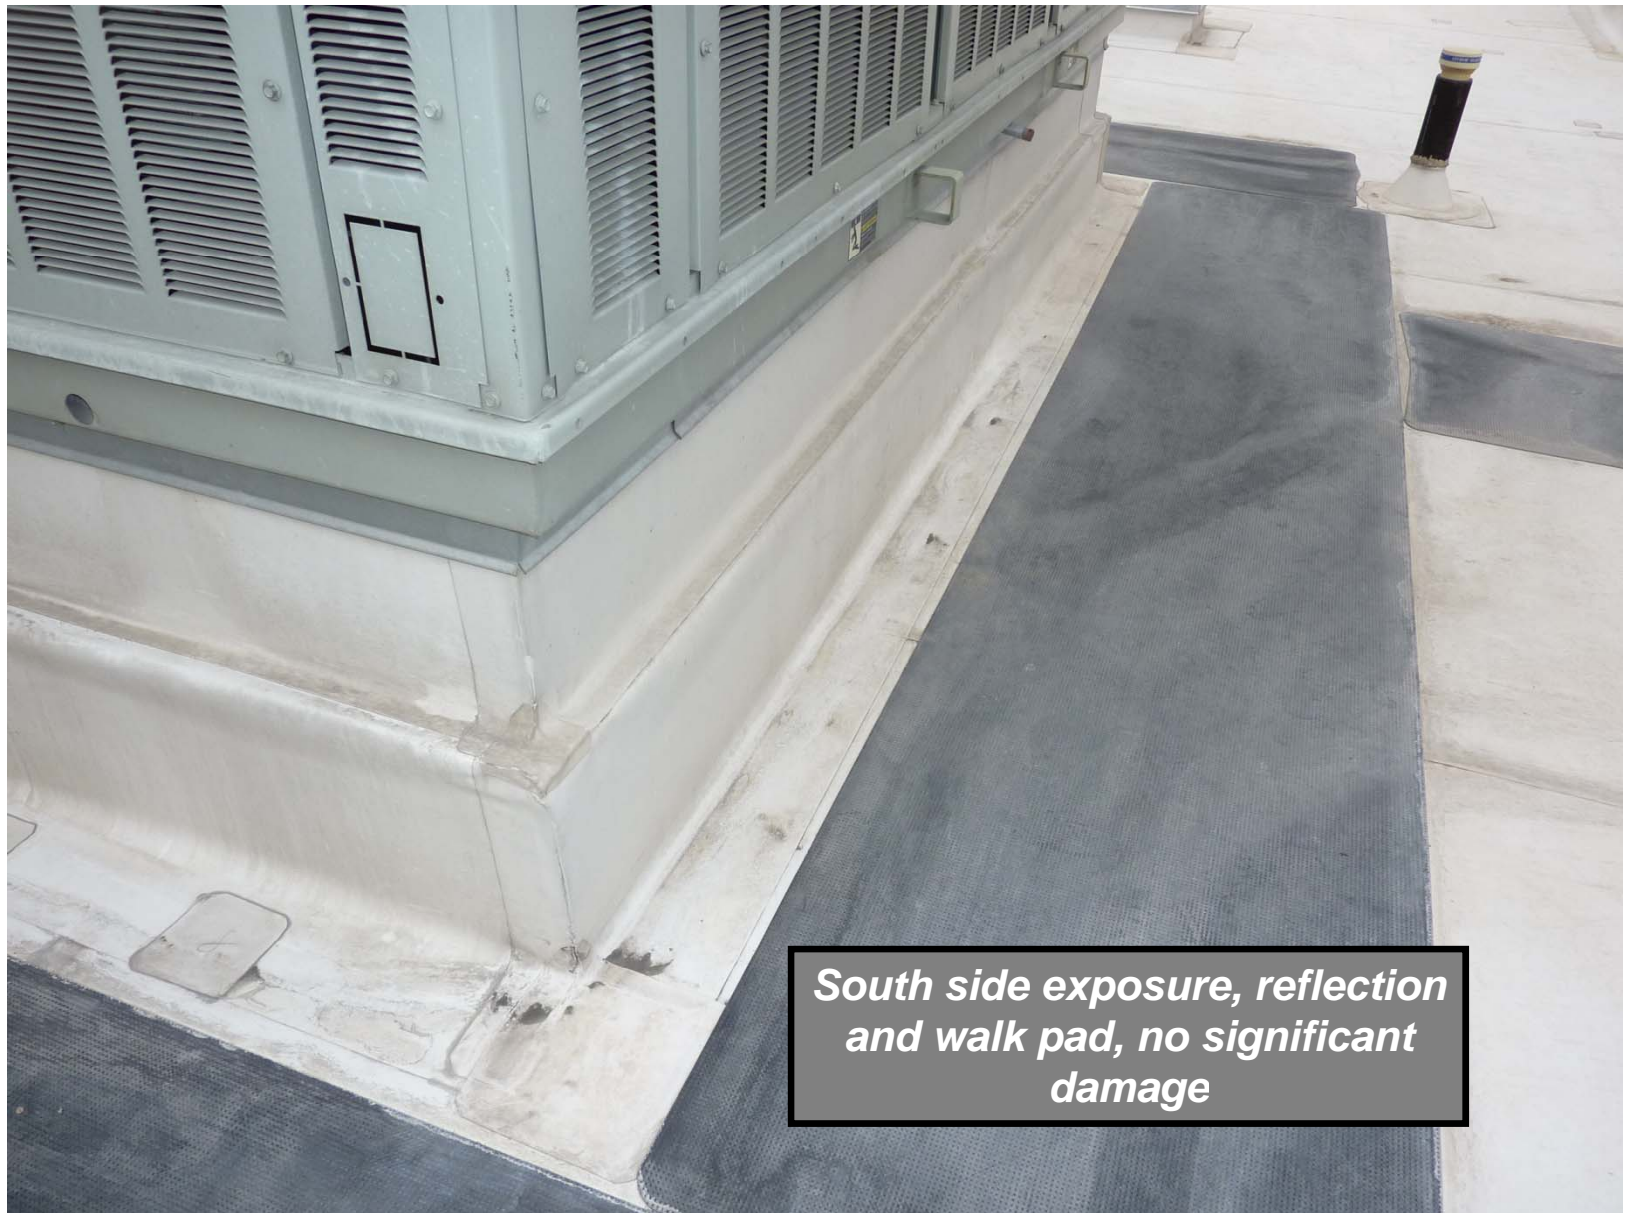
*South side exposure, reflection
and walk pad, no significant
damage*
