**Critical Review of the Life Span of
TPO and PVC
RCI Hawaii Seminar
January 20-21, 2010**

**Karim P. Allana, P.E., RRC, RWC
Allana Buick & Bers, Inc.**

Case Study: PVC

Case Study: TPO

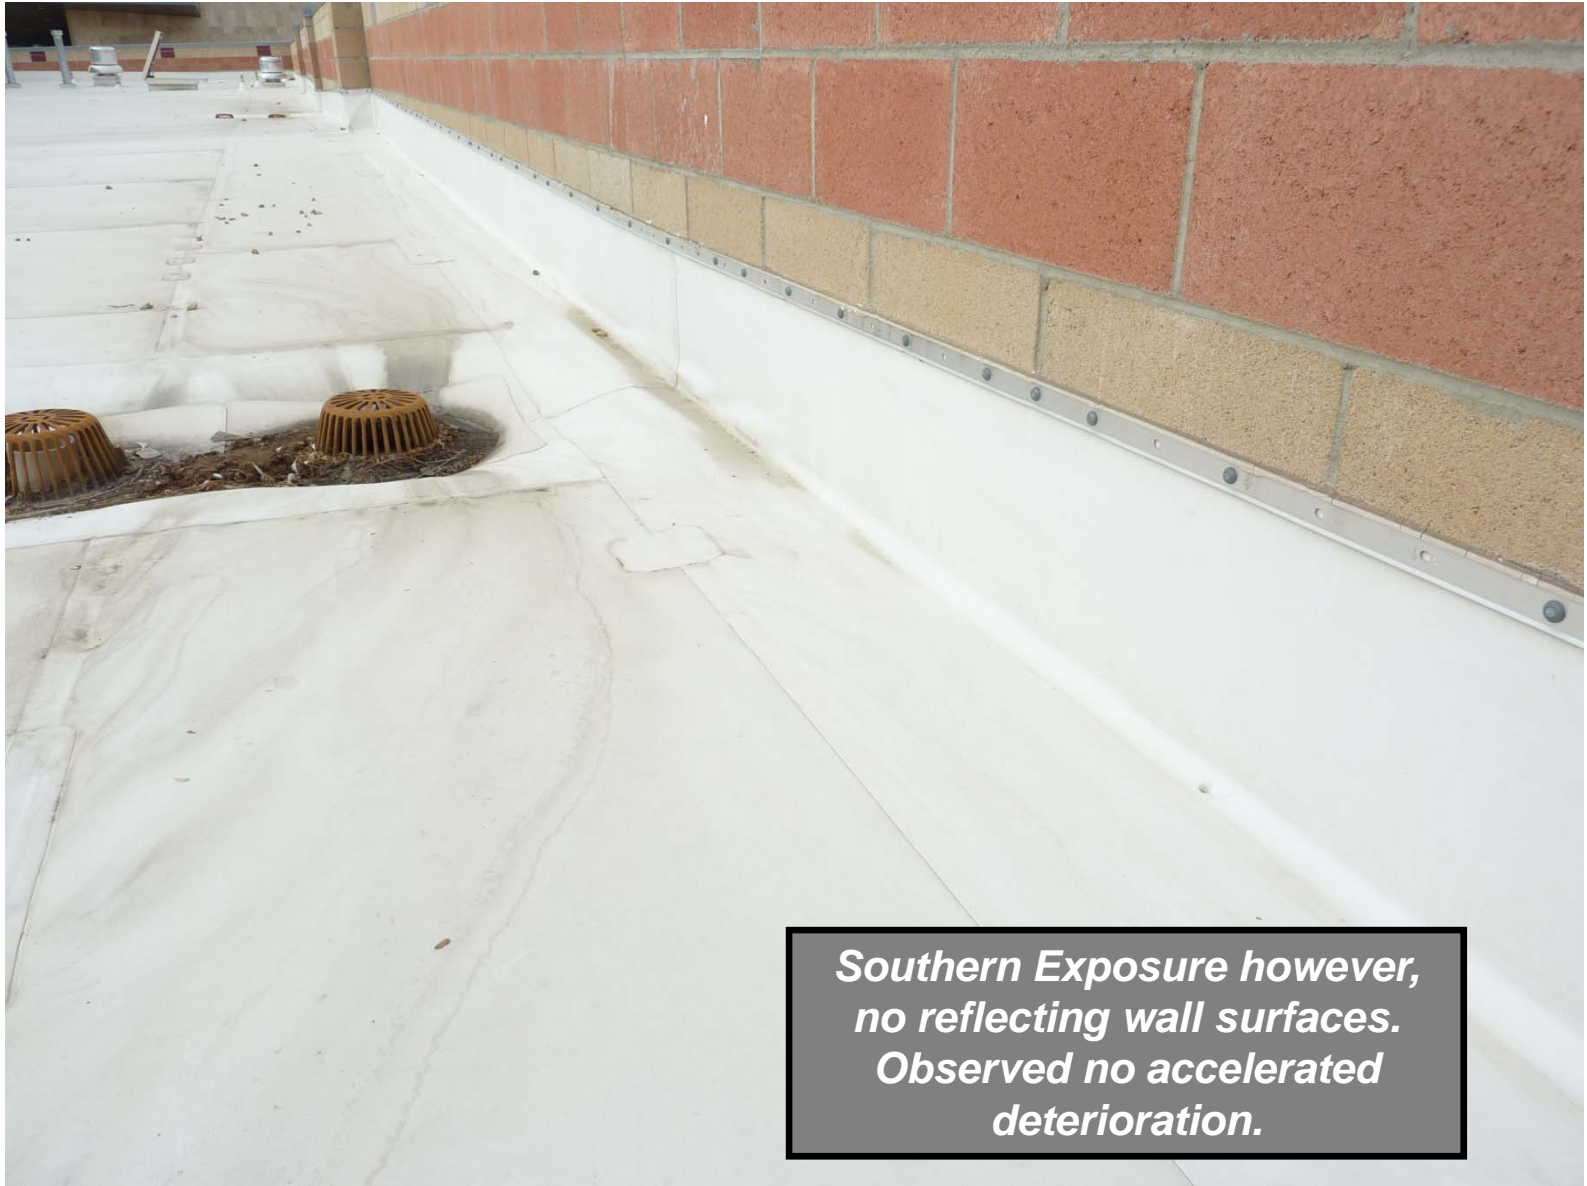
*Southern Exposure however,
no reflecting wall surfaces.
Observed no accelerated
deterioration.*

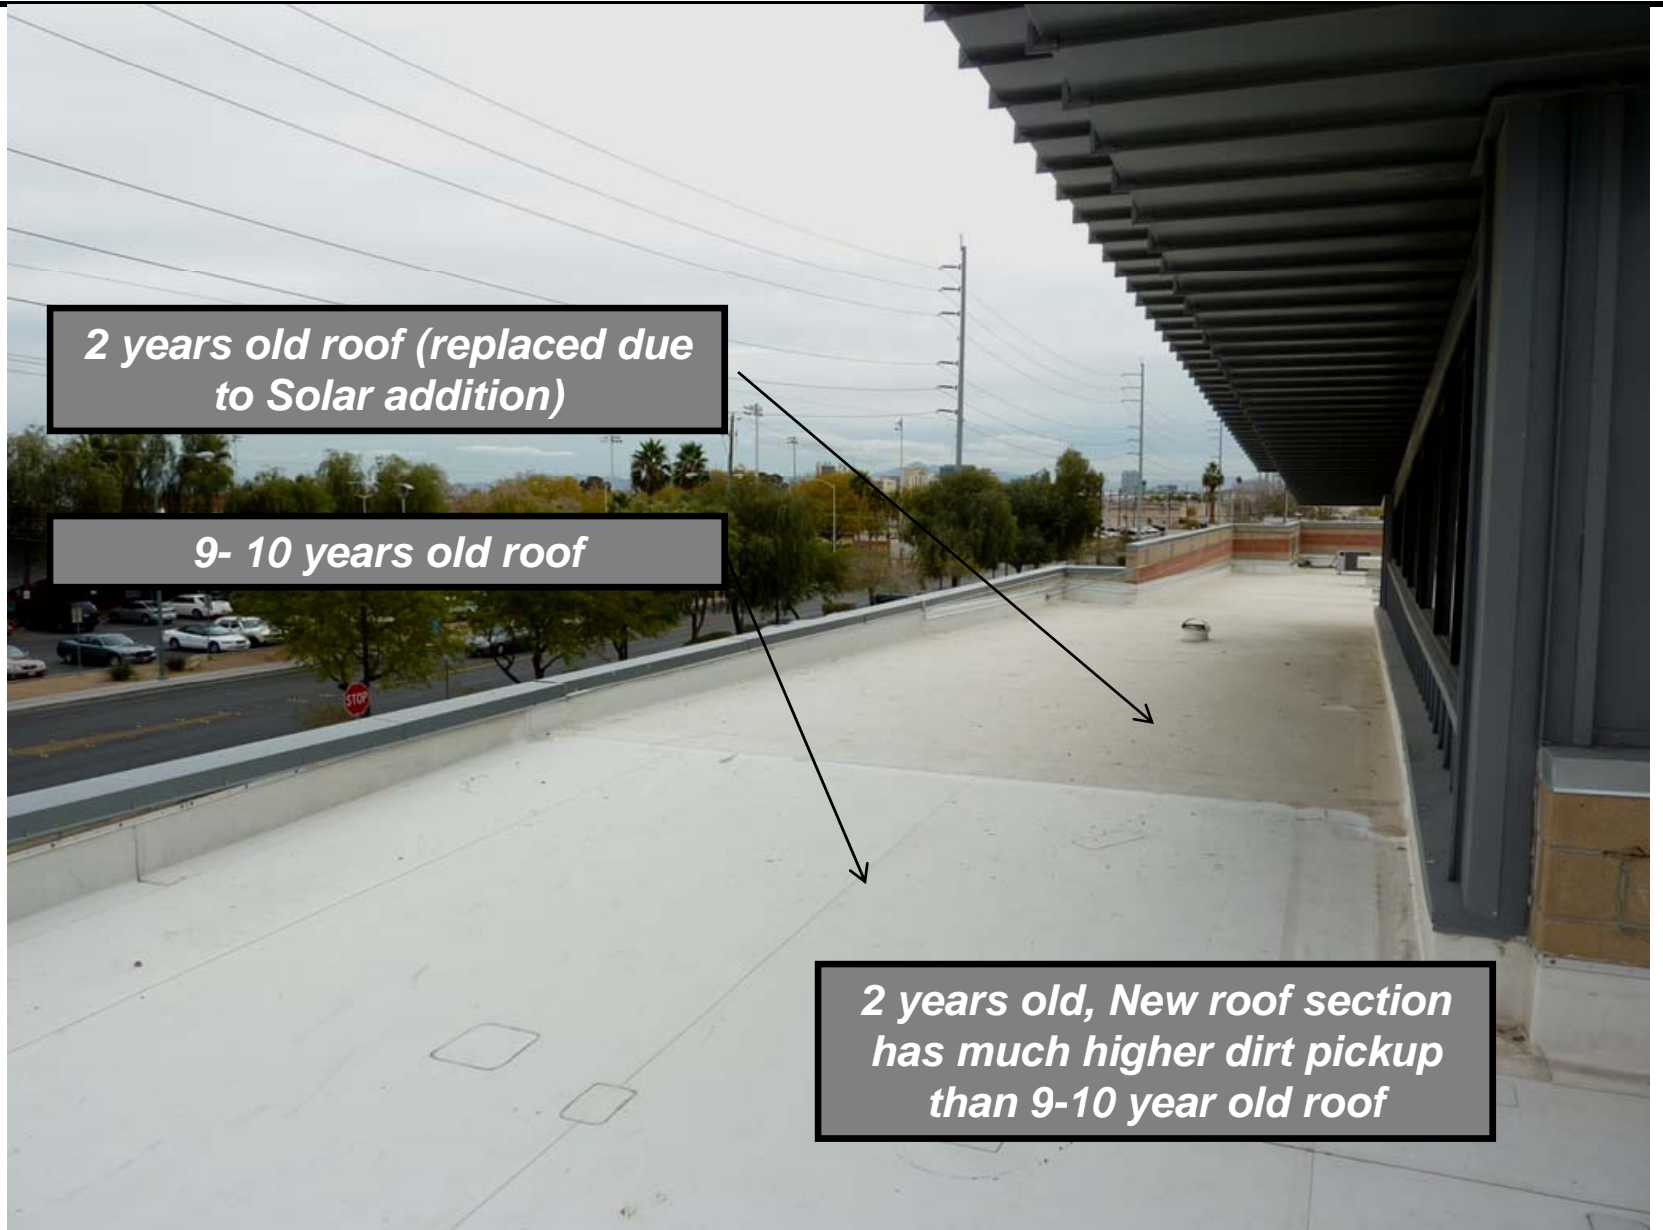
2 years old roof (replaced due to Solar addition)

9- 10 years old roof

2 years old, New roof section has much higher dirt pickup than 9-10 year old roof

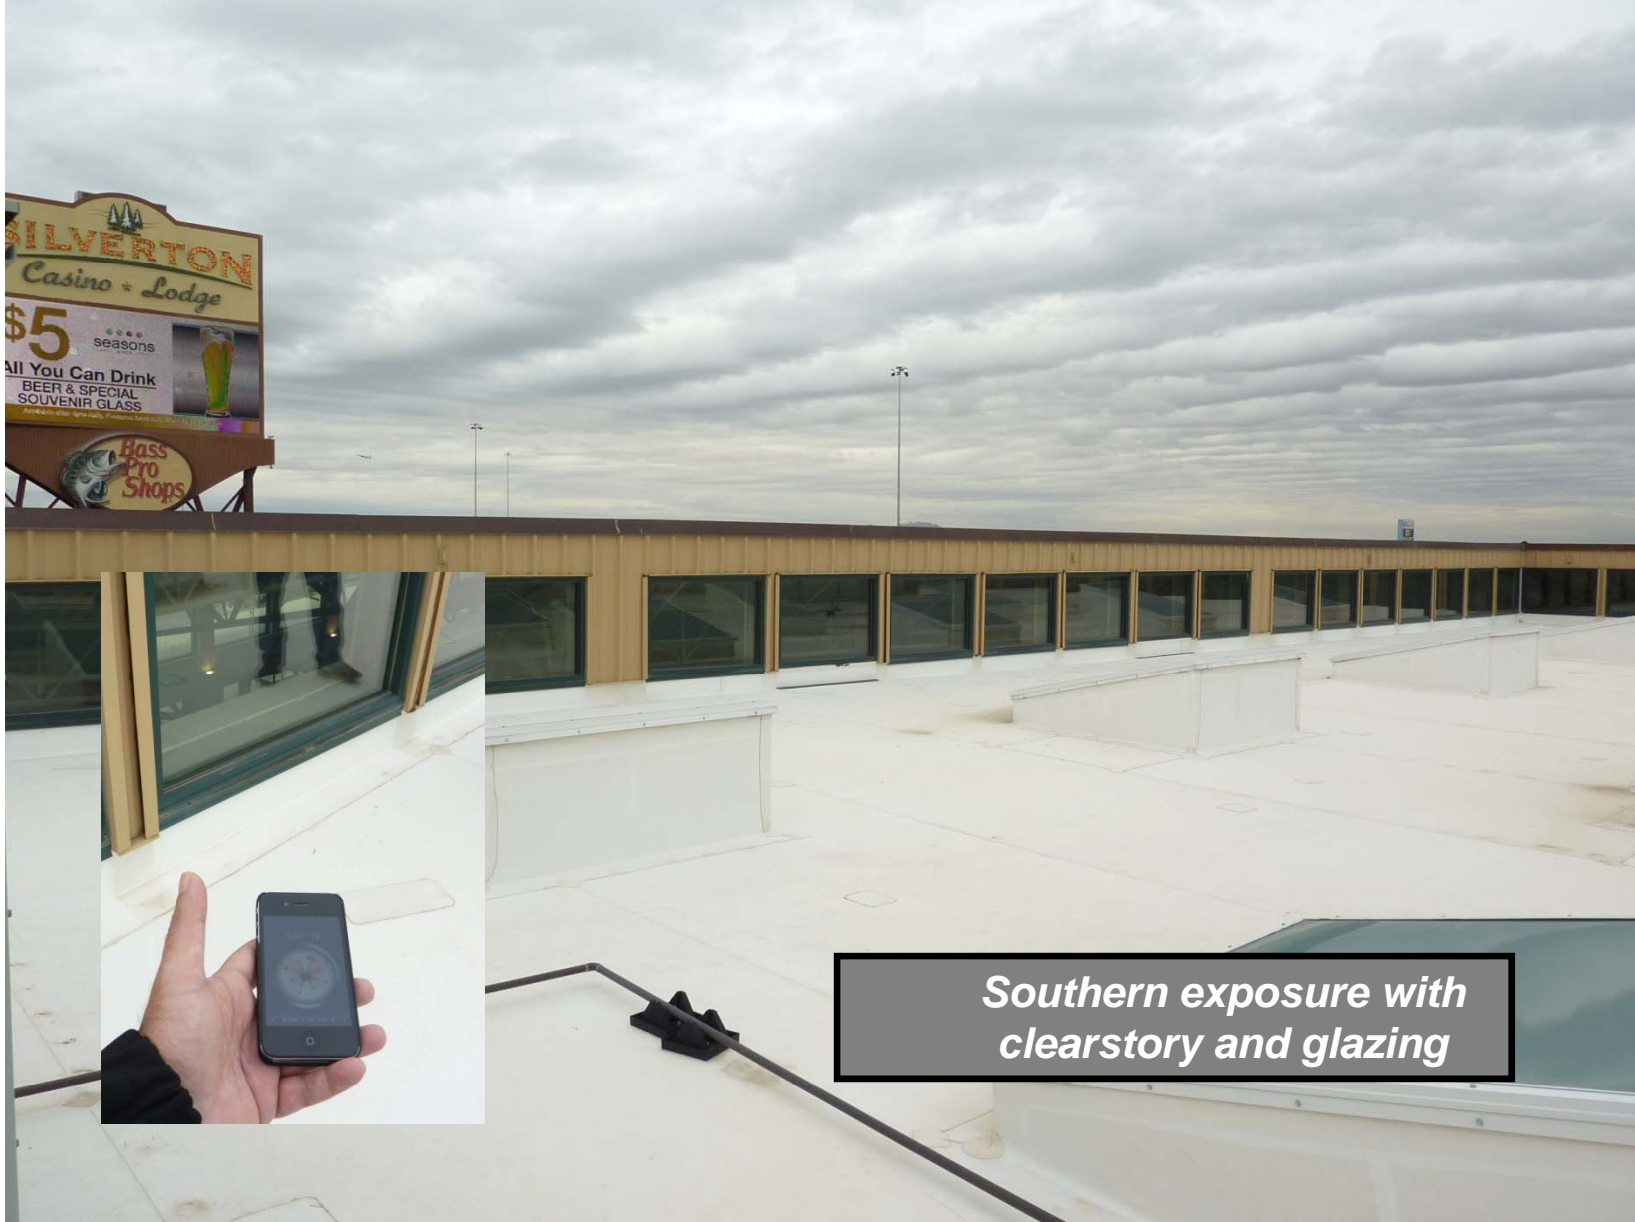
Southern exposure with clearstory and glazing

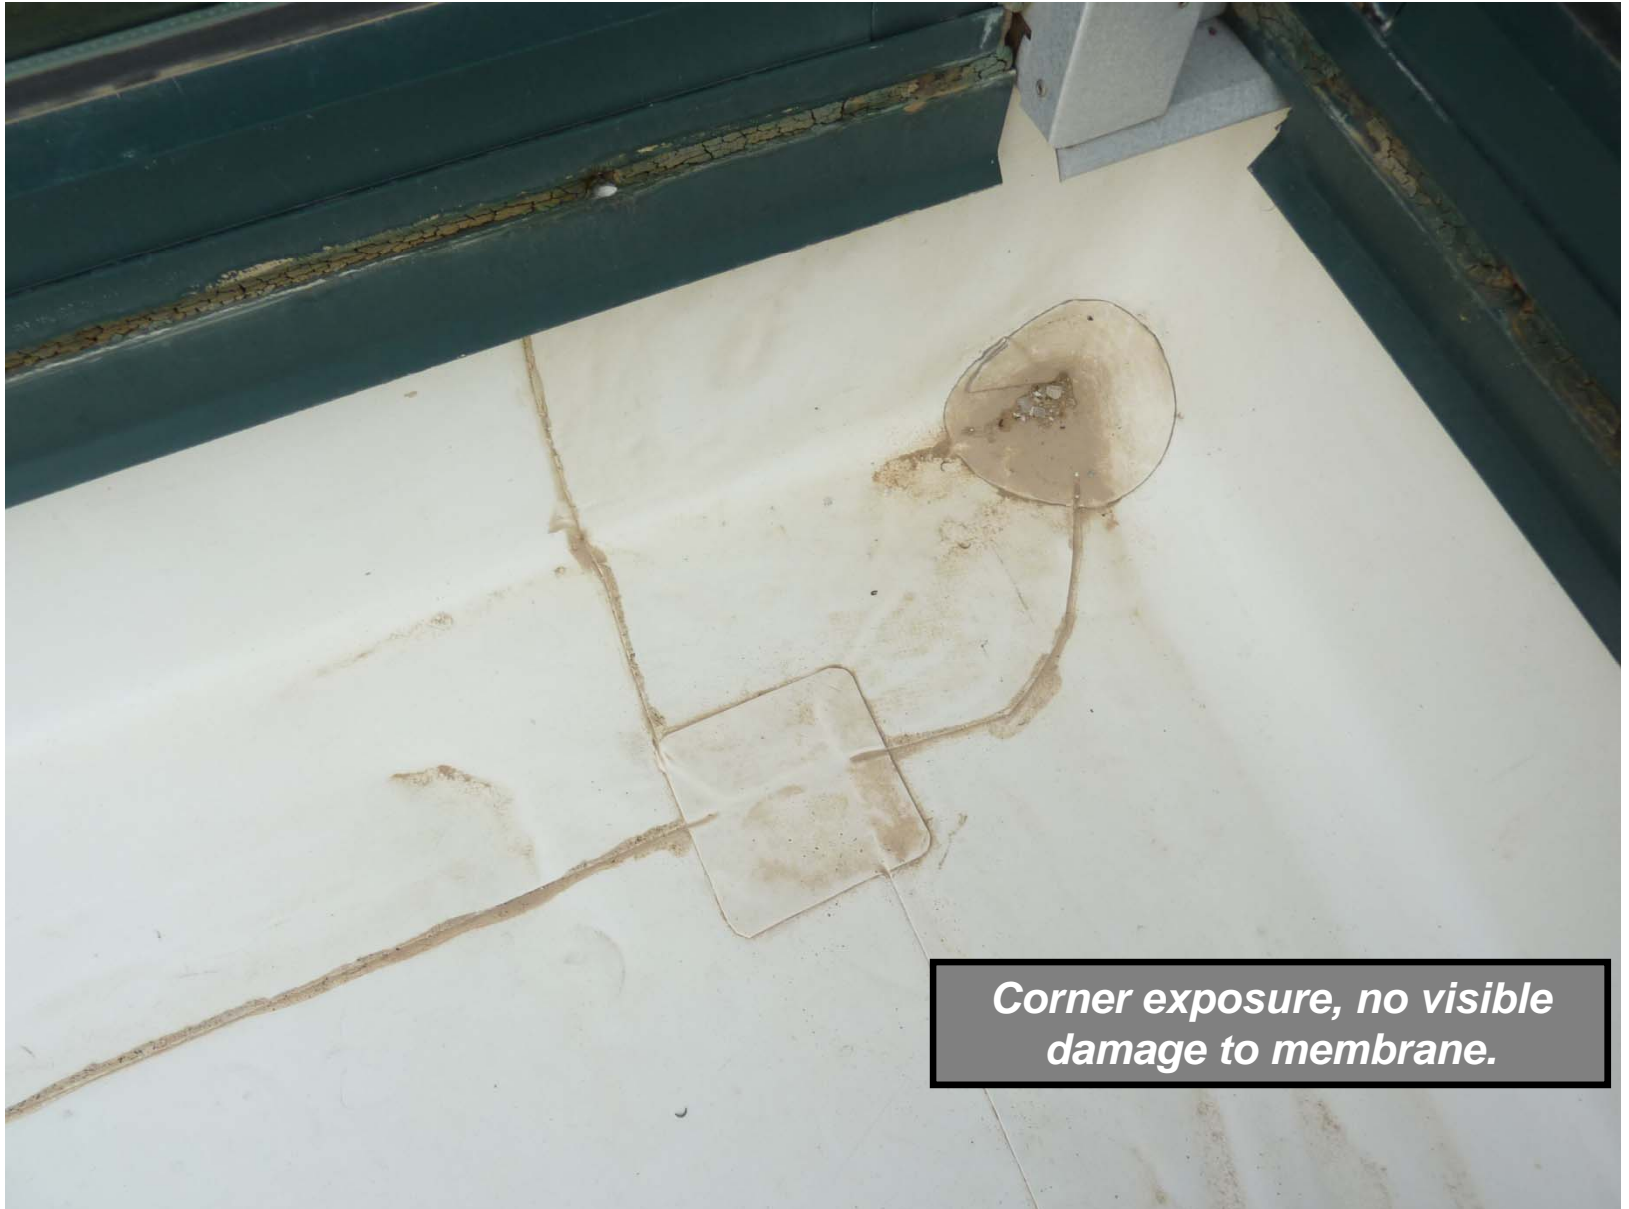
Corner exposure, no visible damage to membrane.

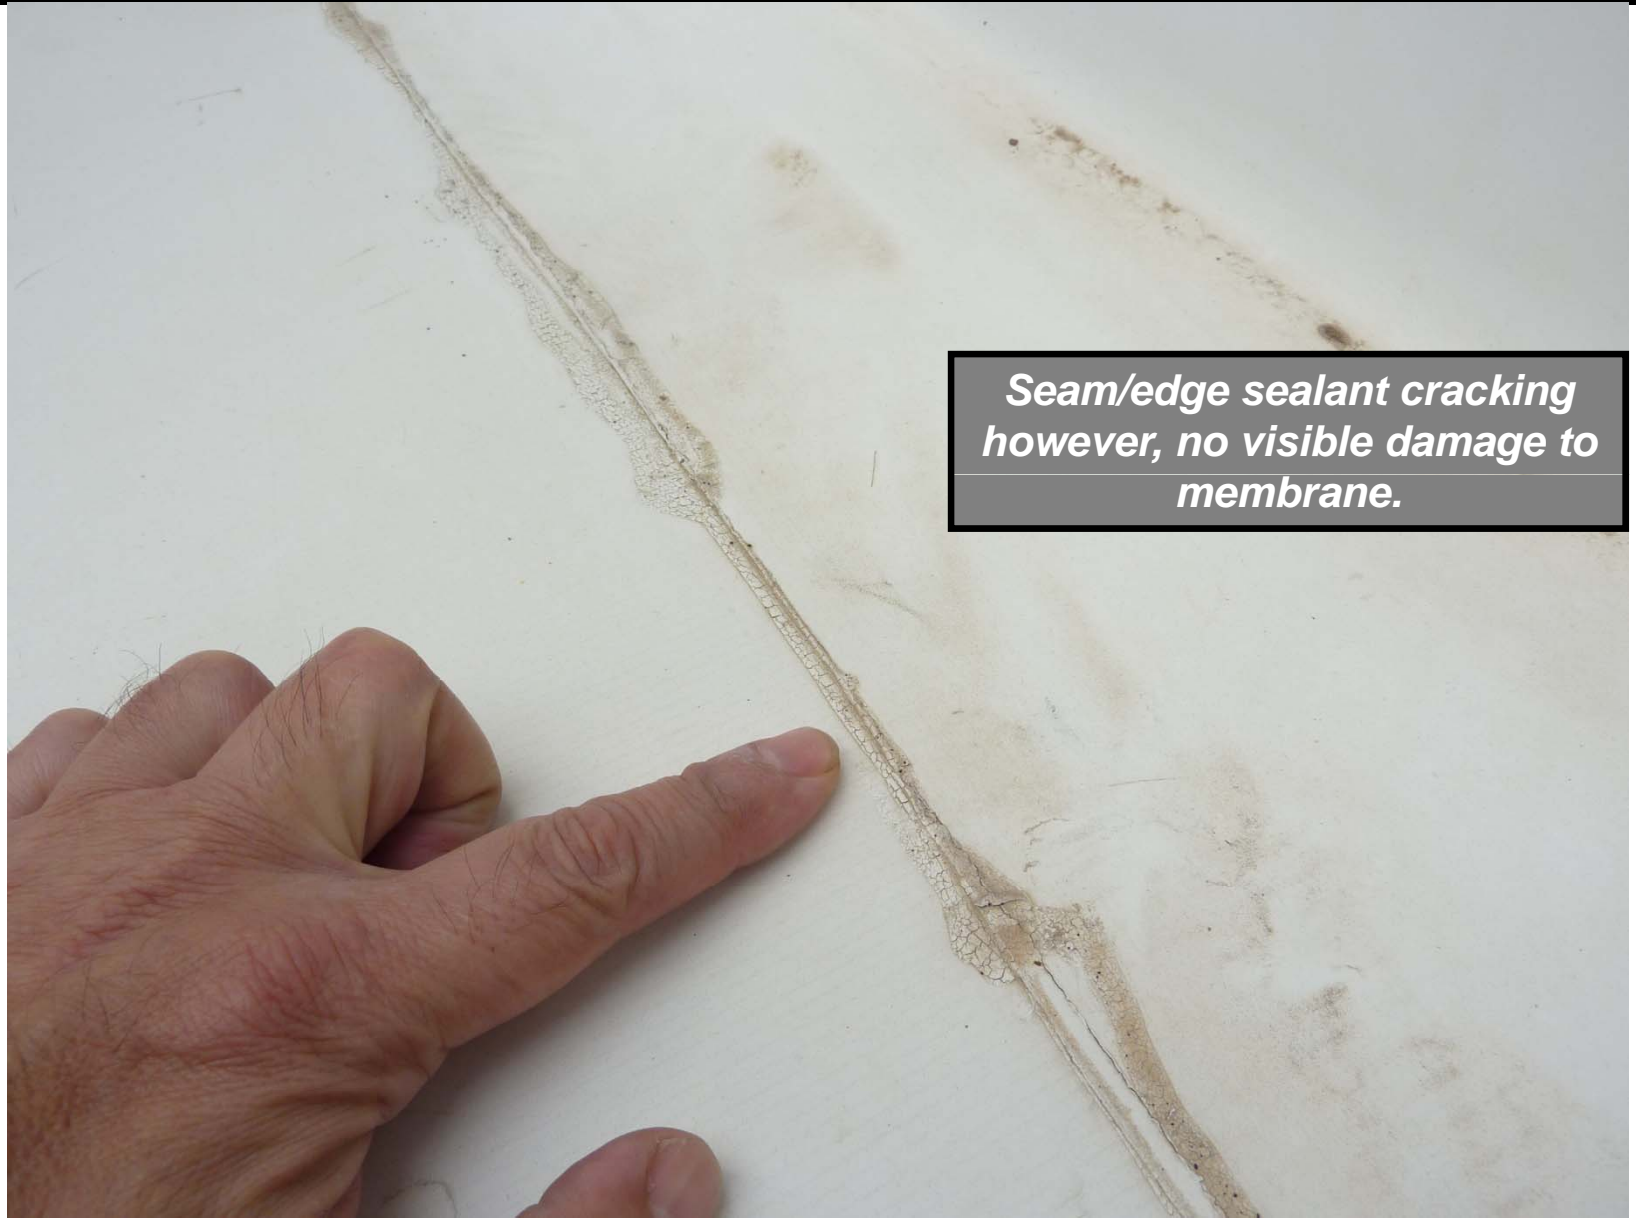
*Seam/edge sealant cracking
however, no visible damage to
membrane.*

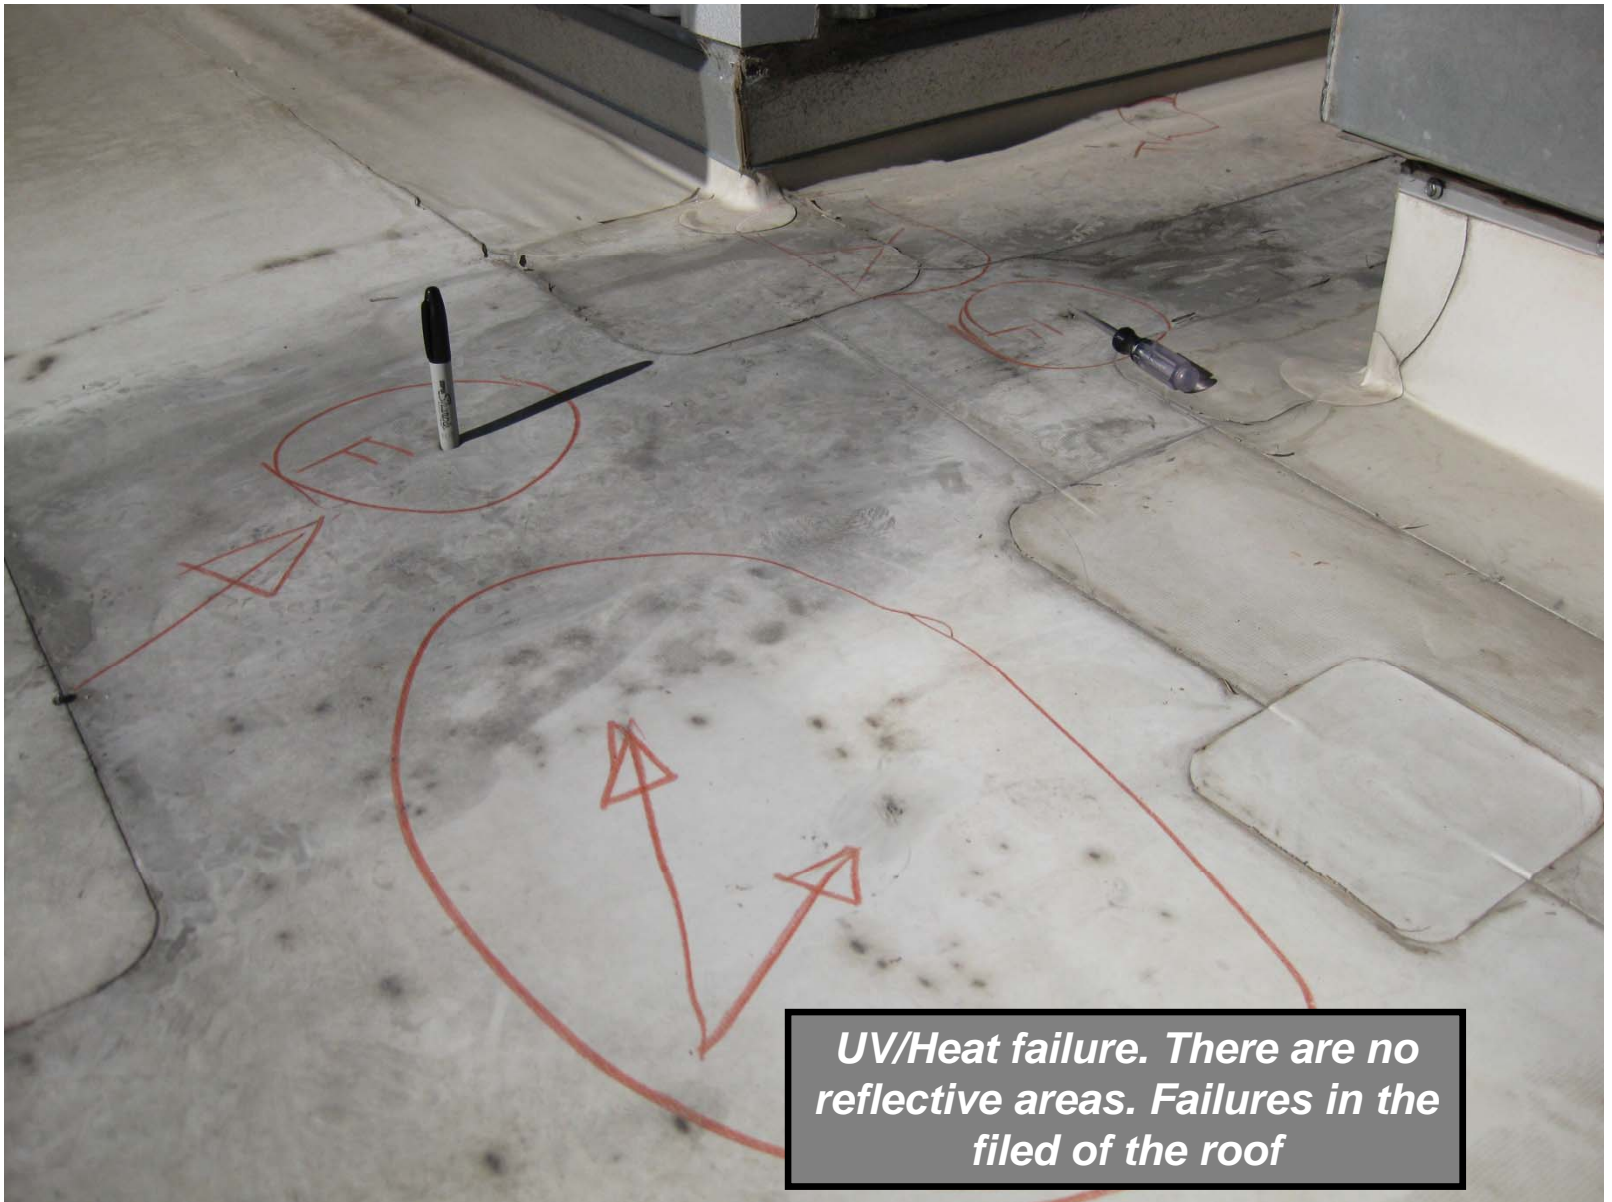
UV/Heat failure. There are no reflective areas. Failures in the field of the roof

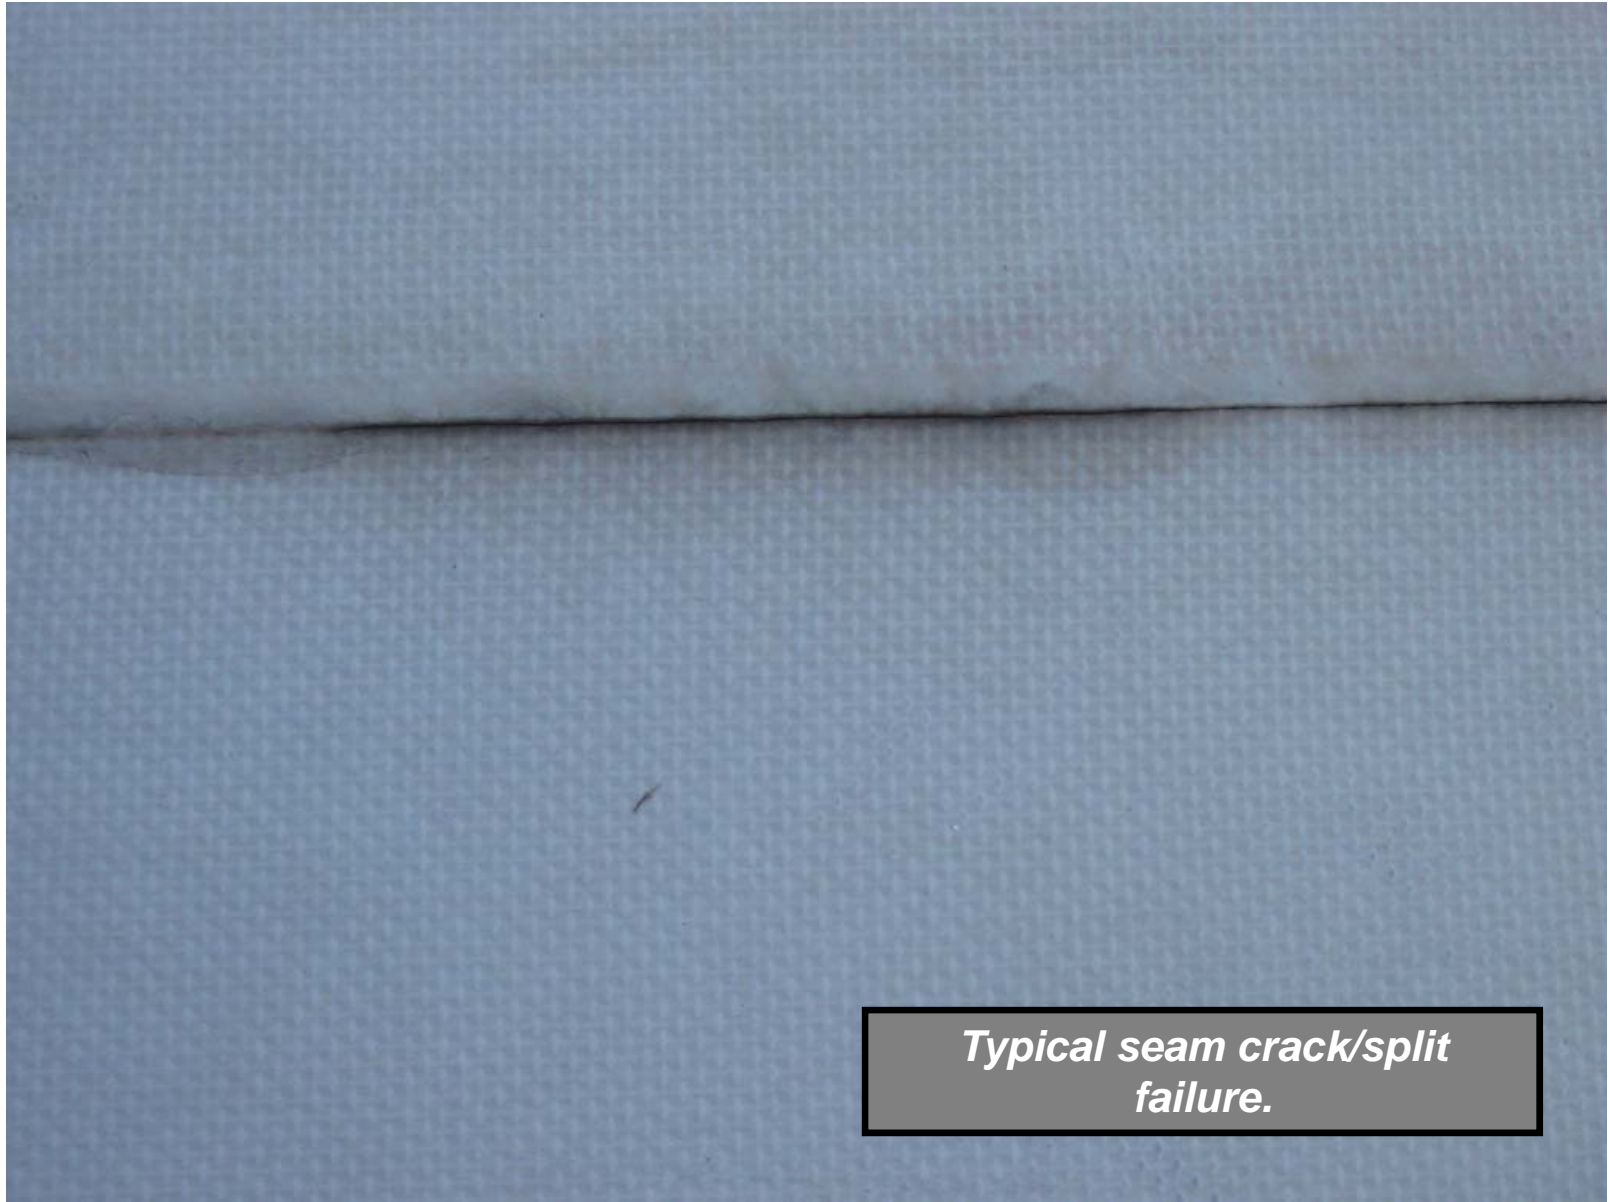
Typical seam crack/split failure.

- Appears to be limited to some manufacturers
- Failures were observed in JP Stevens and Johns Manville

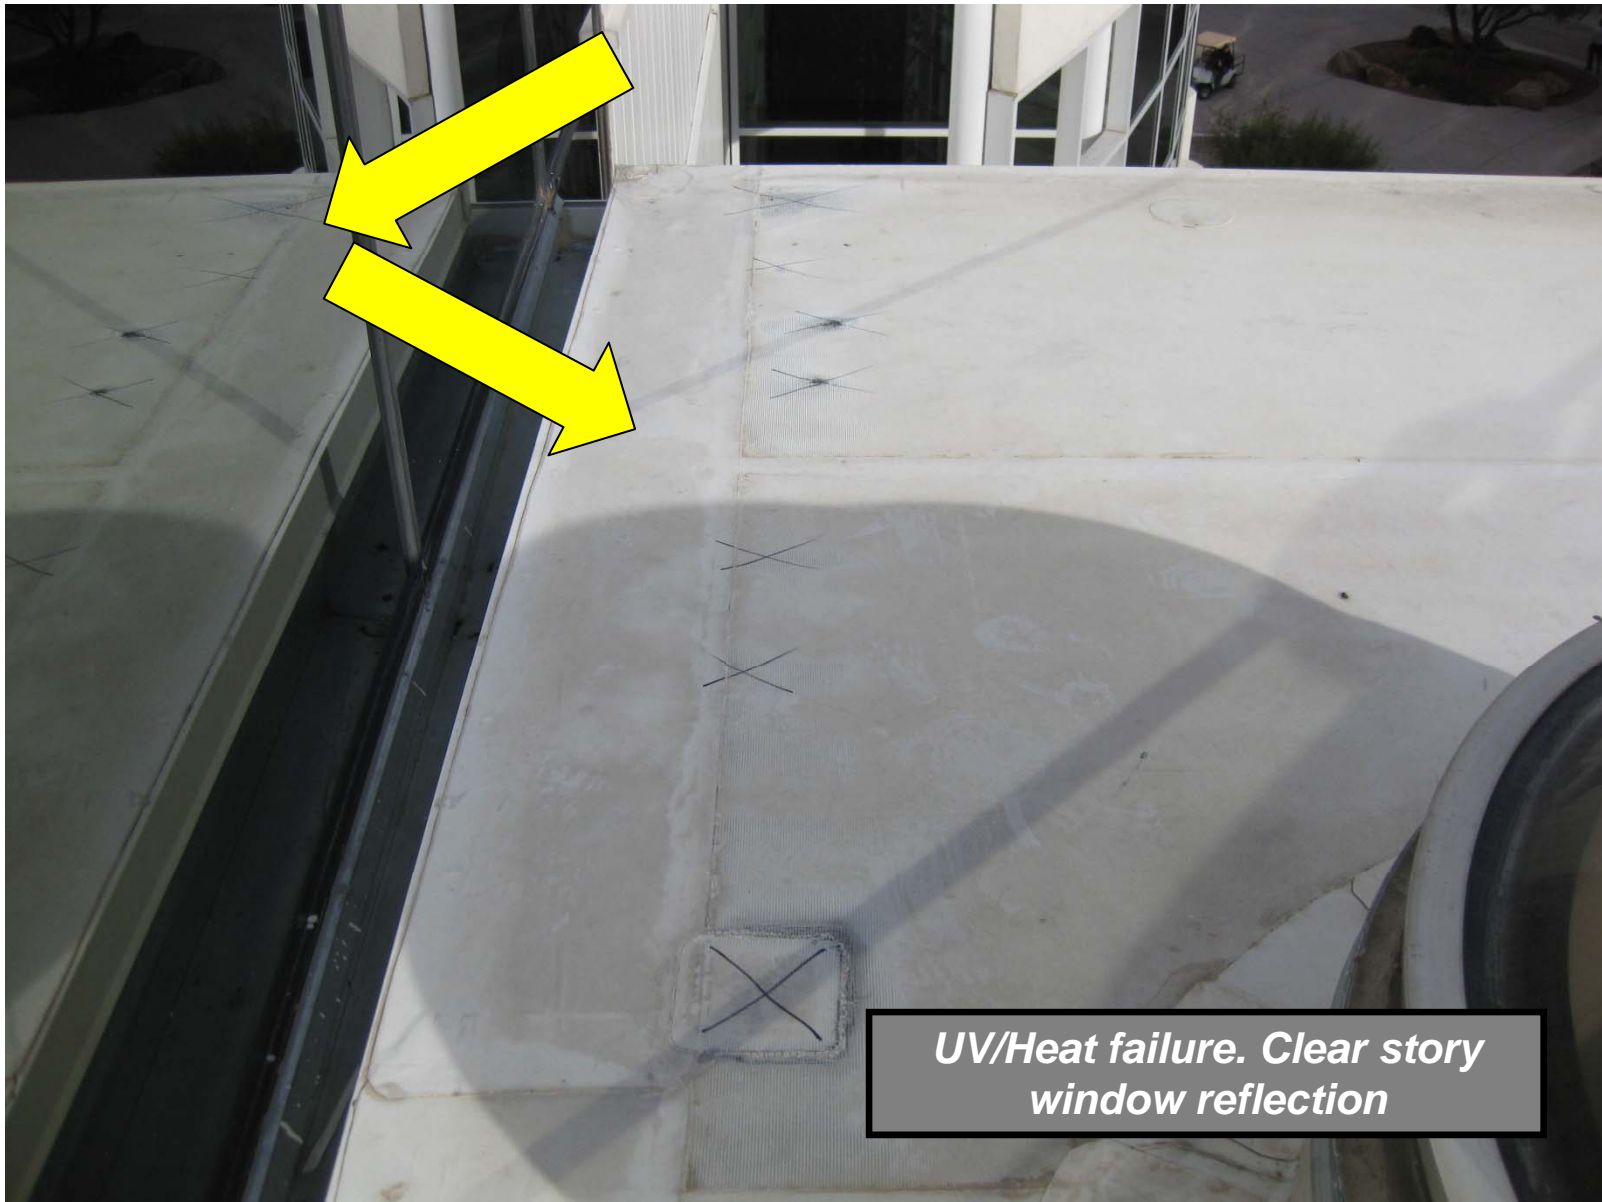
UV/Heat failure. Clear story window reflection

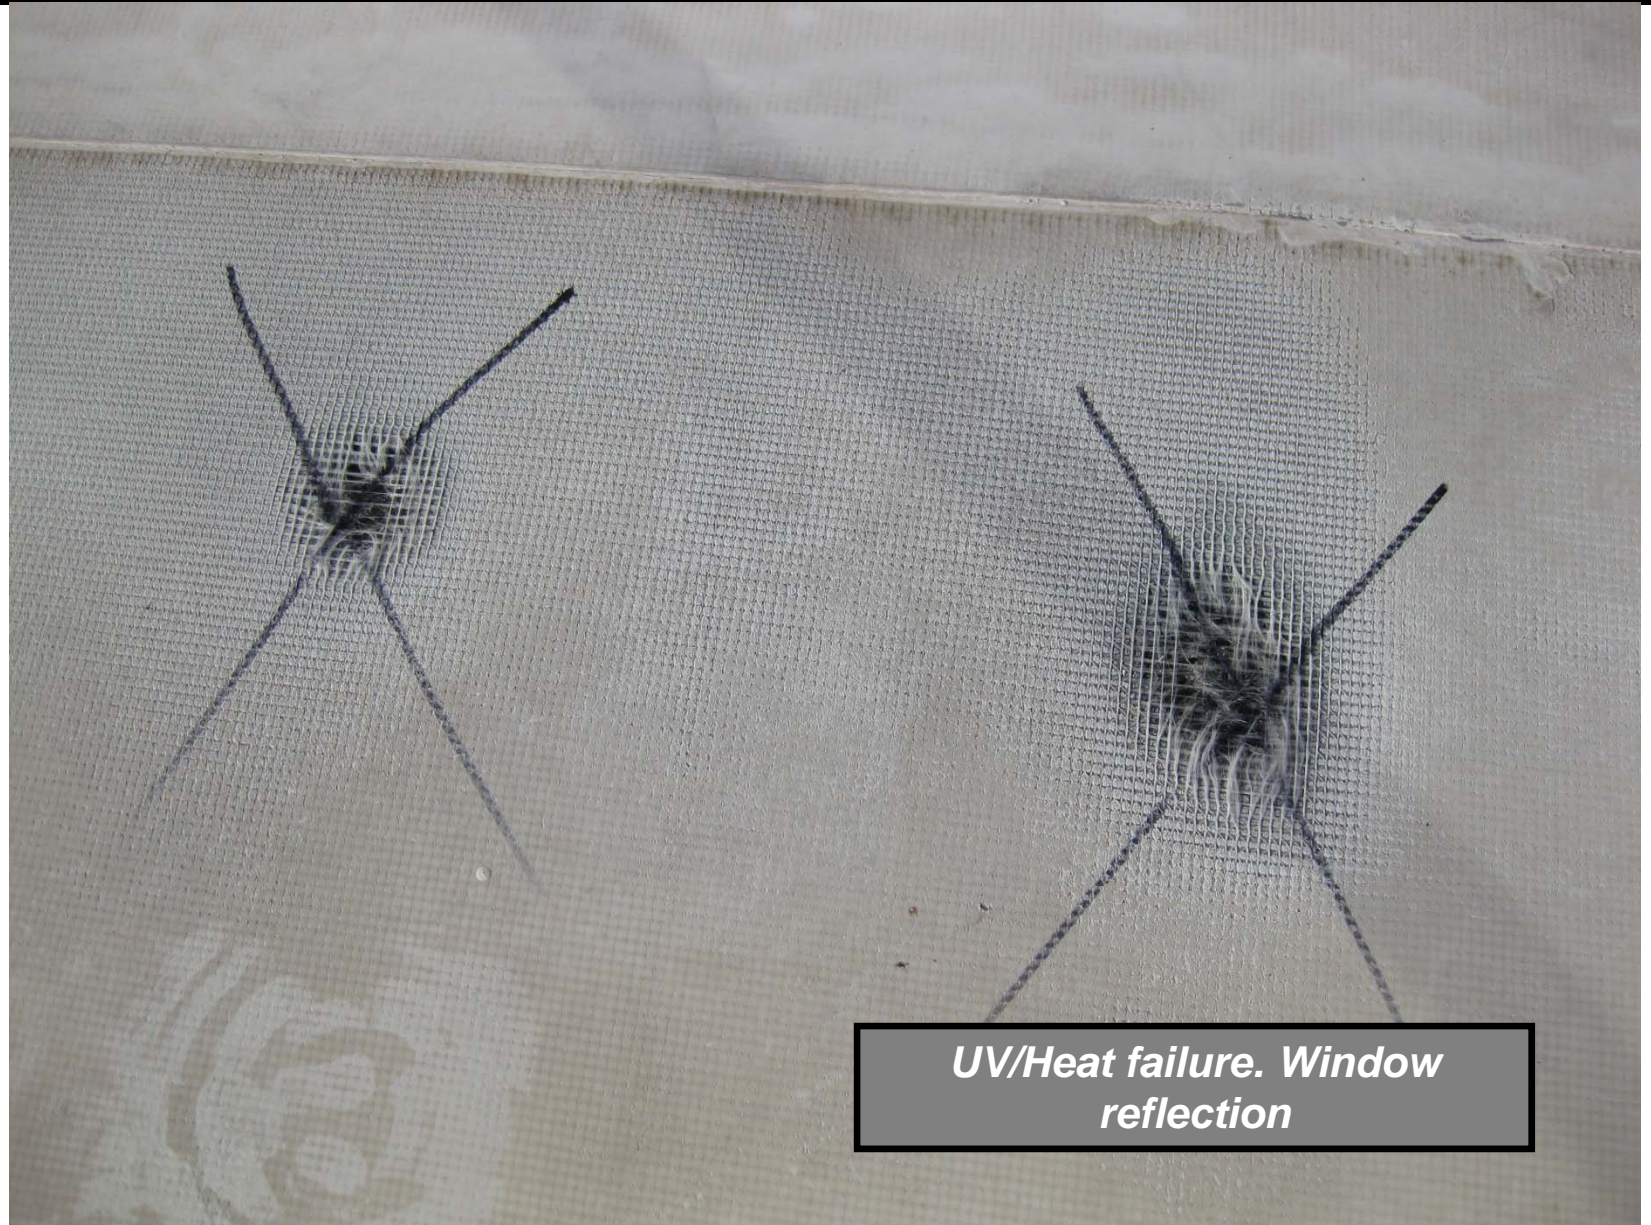
UV/Heat failure. Window reflection

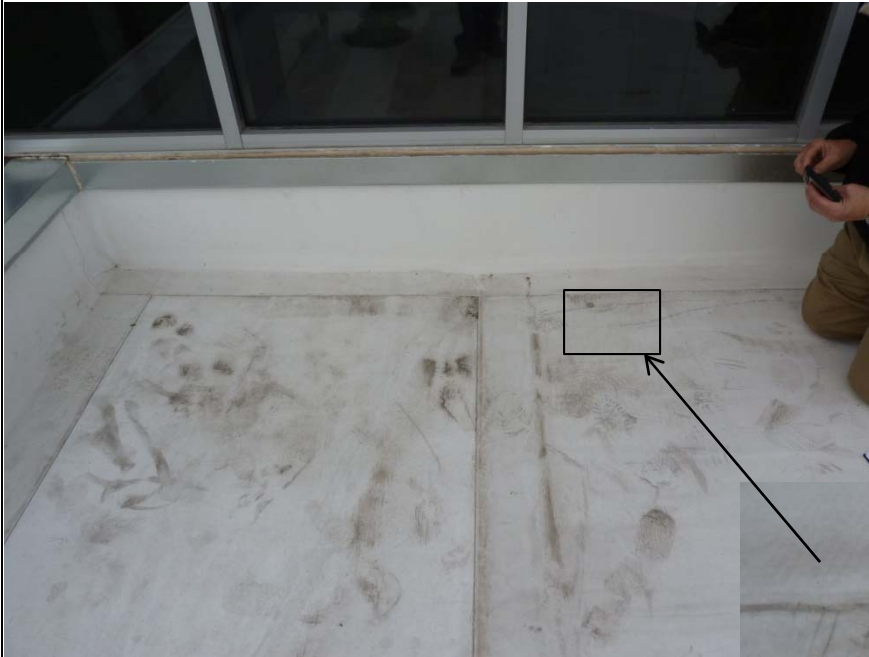
This replacement GAF roof is less than 3 years old!

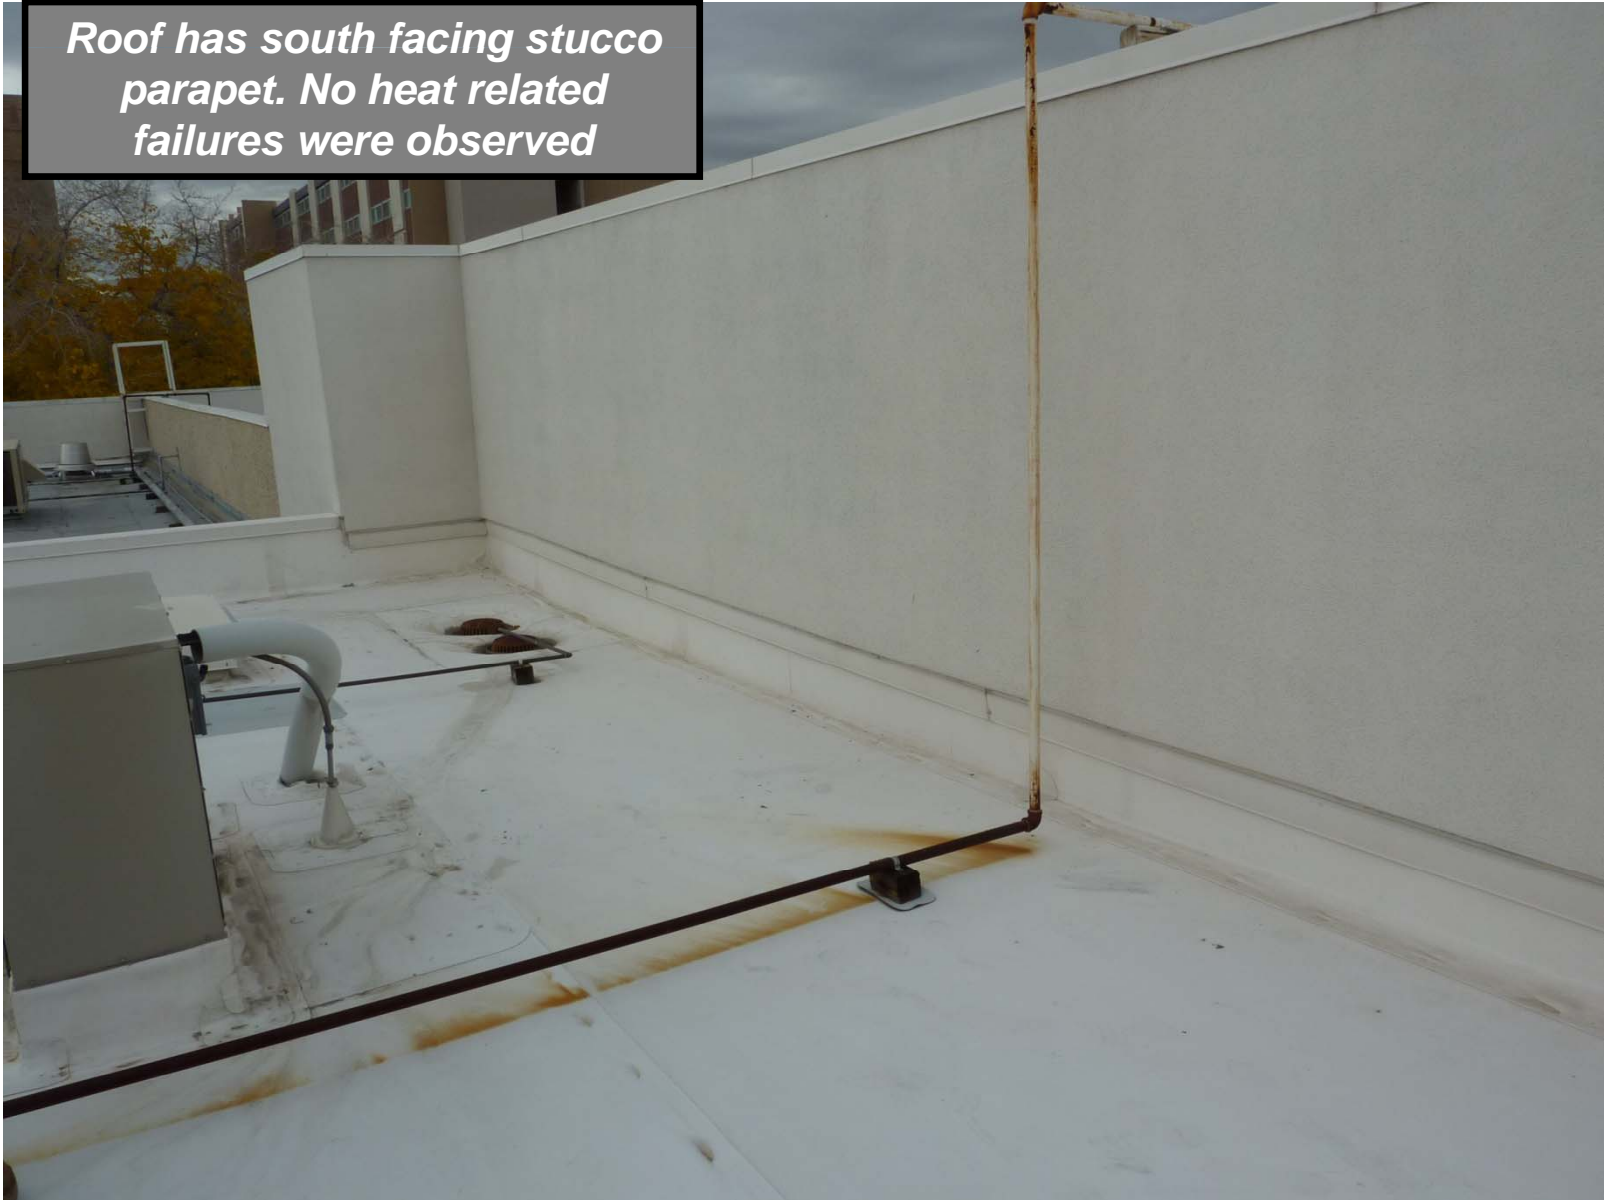
Roof has south facing stucco parapet. No heat related failures were observed

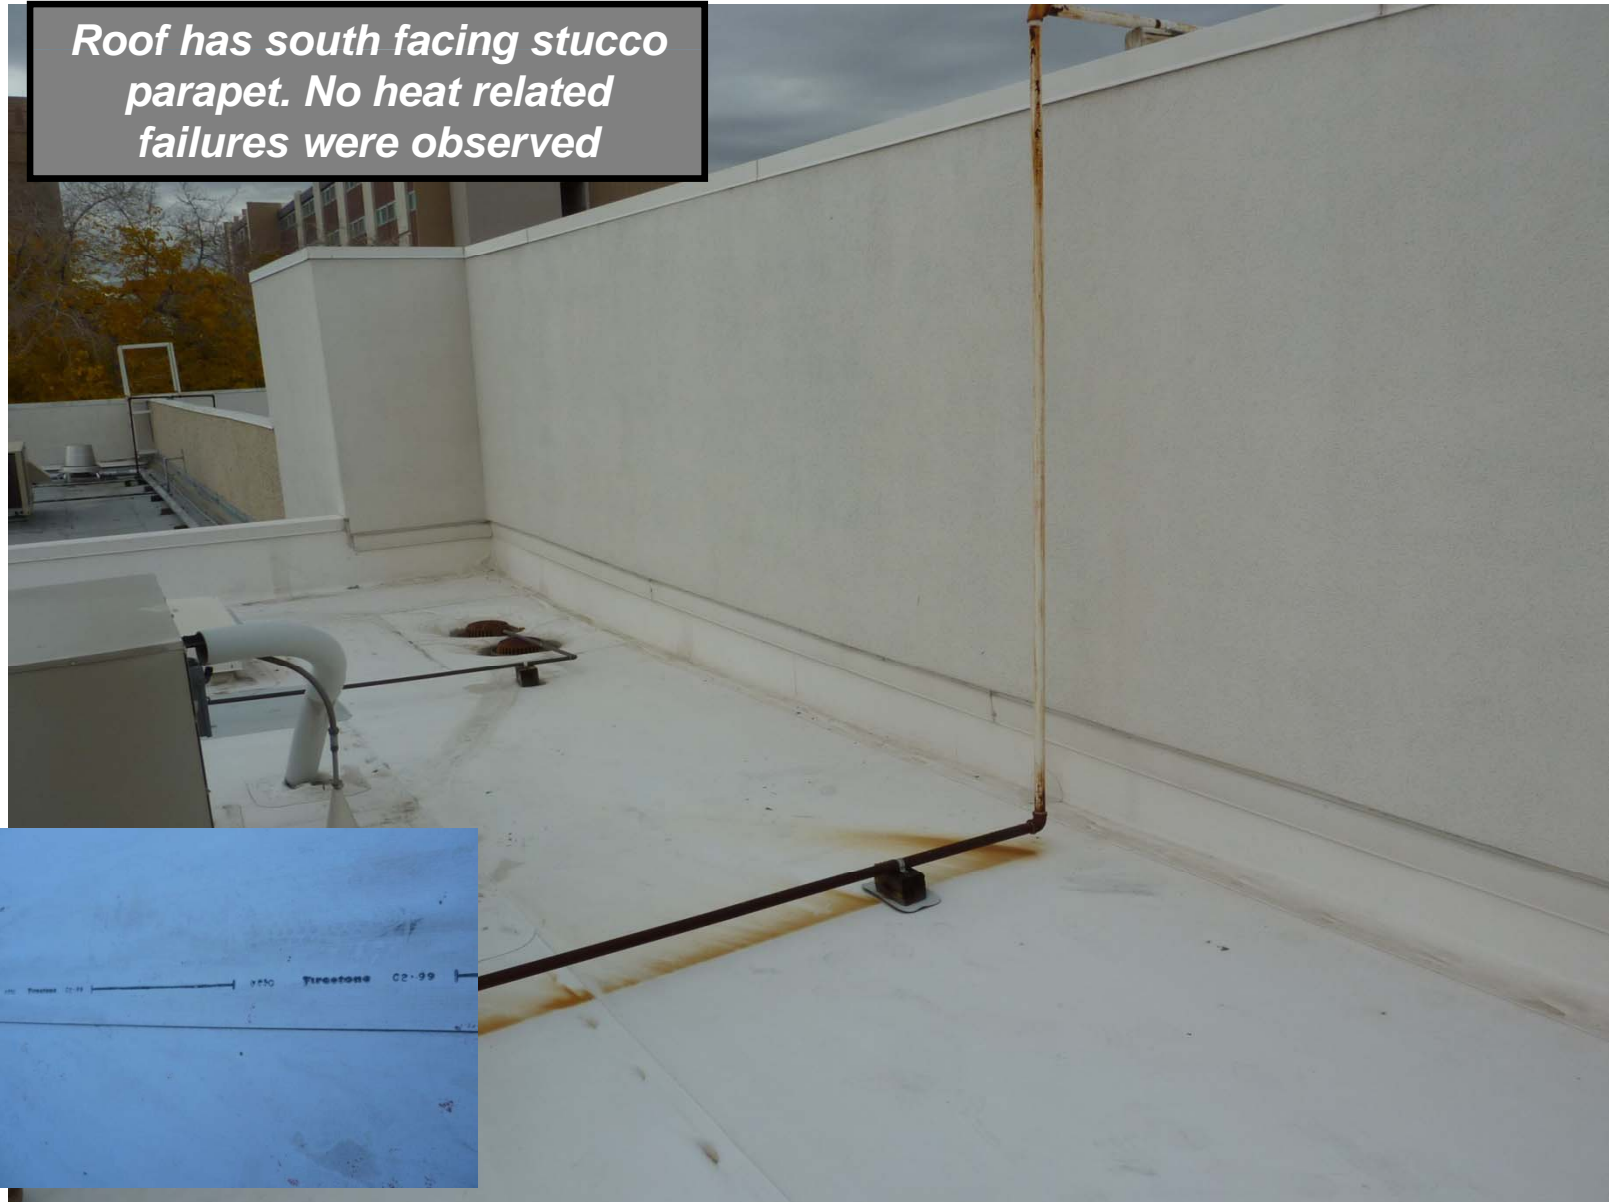
Roof has south facing stucco parapet. No heat related failures were observed

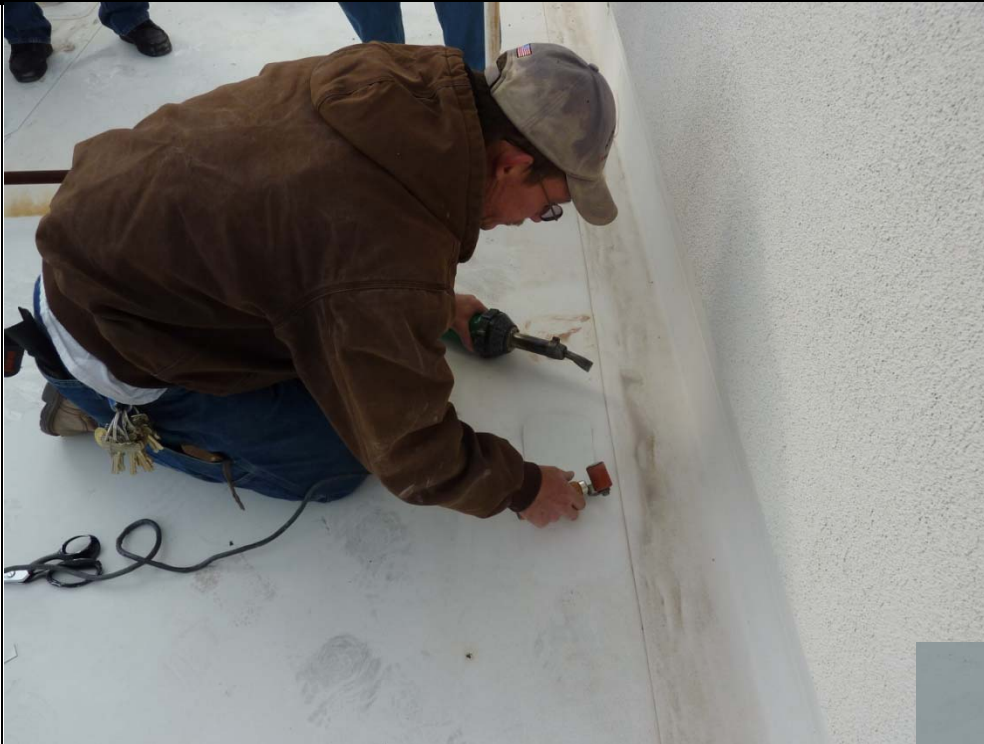
While there were no heat related failures, all attempts to heat weld/patch the roof were unsuccessful.
