**Critical Review of the Life Span of
TPO and PVC
RCI Hawaii Seminar
January 20-21, 2010**

**Karim P. Allana, P.E., RRC, RWC
Allana Buick & Bers, Inc.**

Case Study: PVC

Case Study: TPO

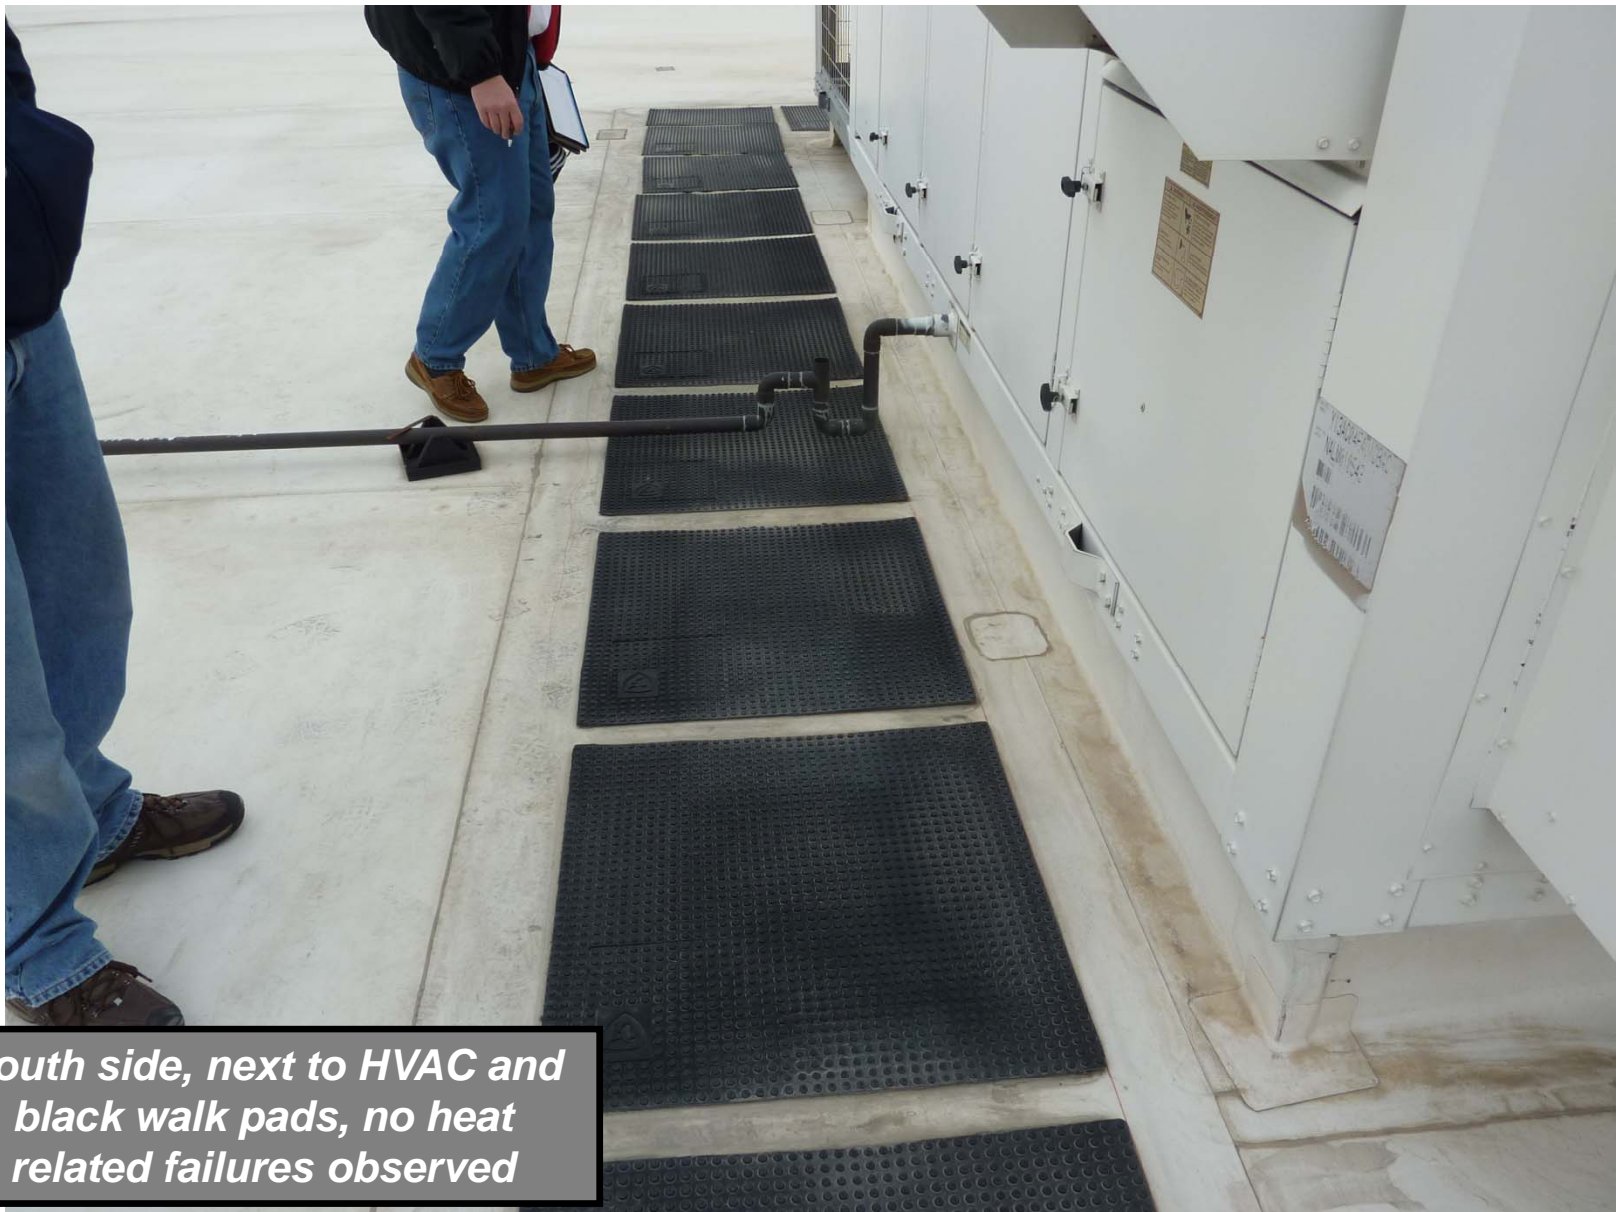
*South side, next to HVAC and
black walk pads, no heat
related failures observed*

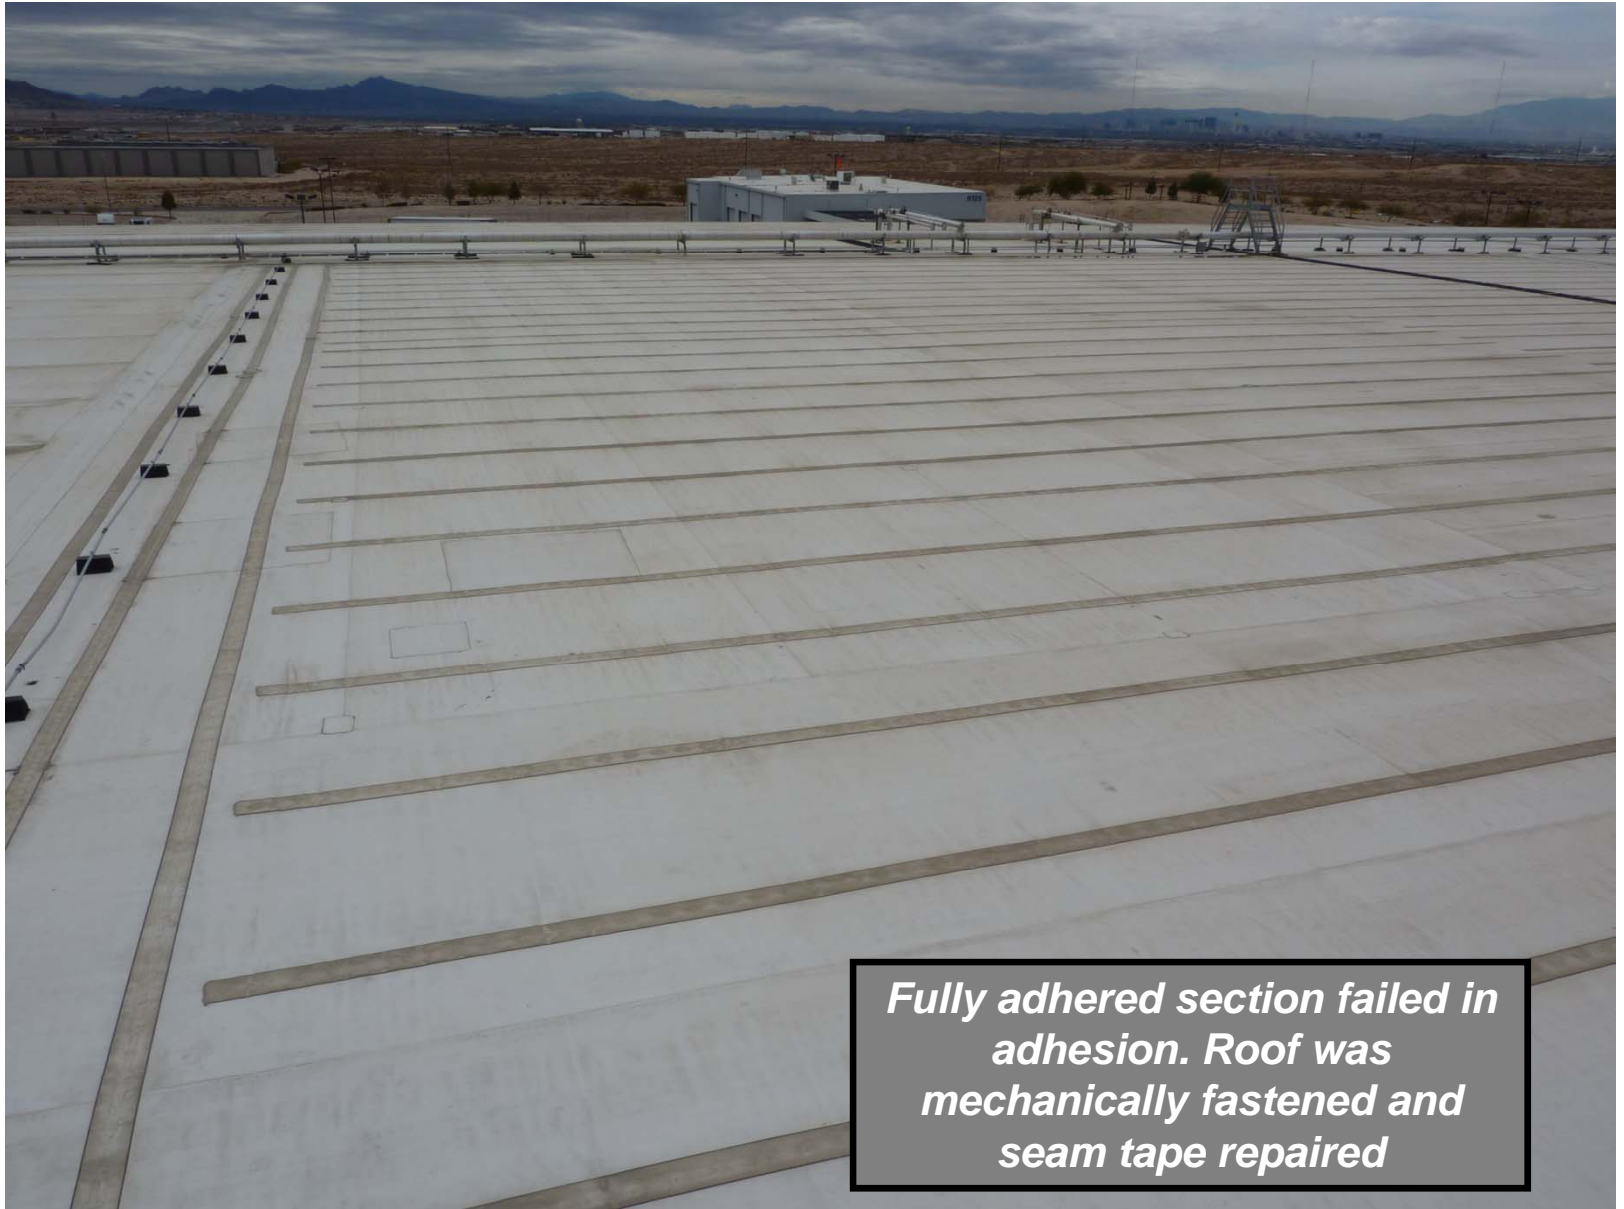
*Fully adhered section failed in
adhesion. Roof was
mechanically fastened and
seam tape repaired*

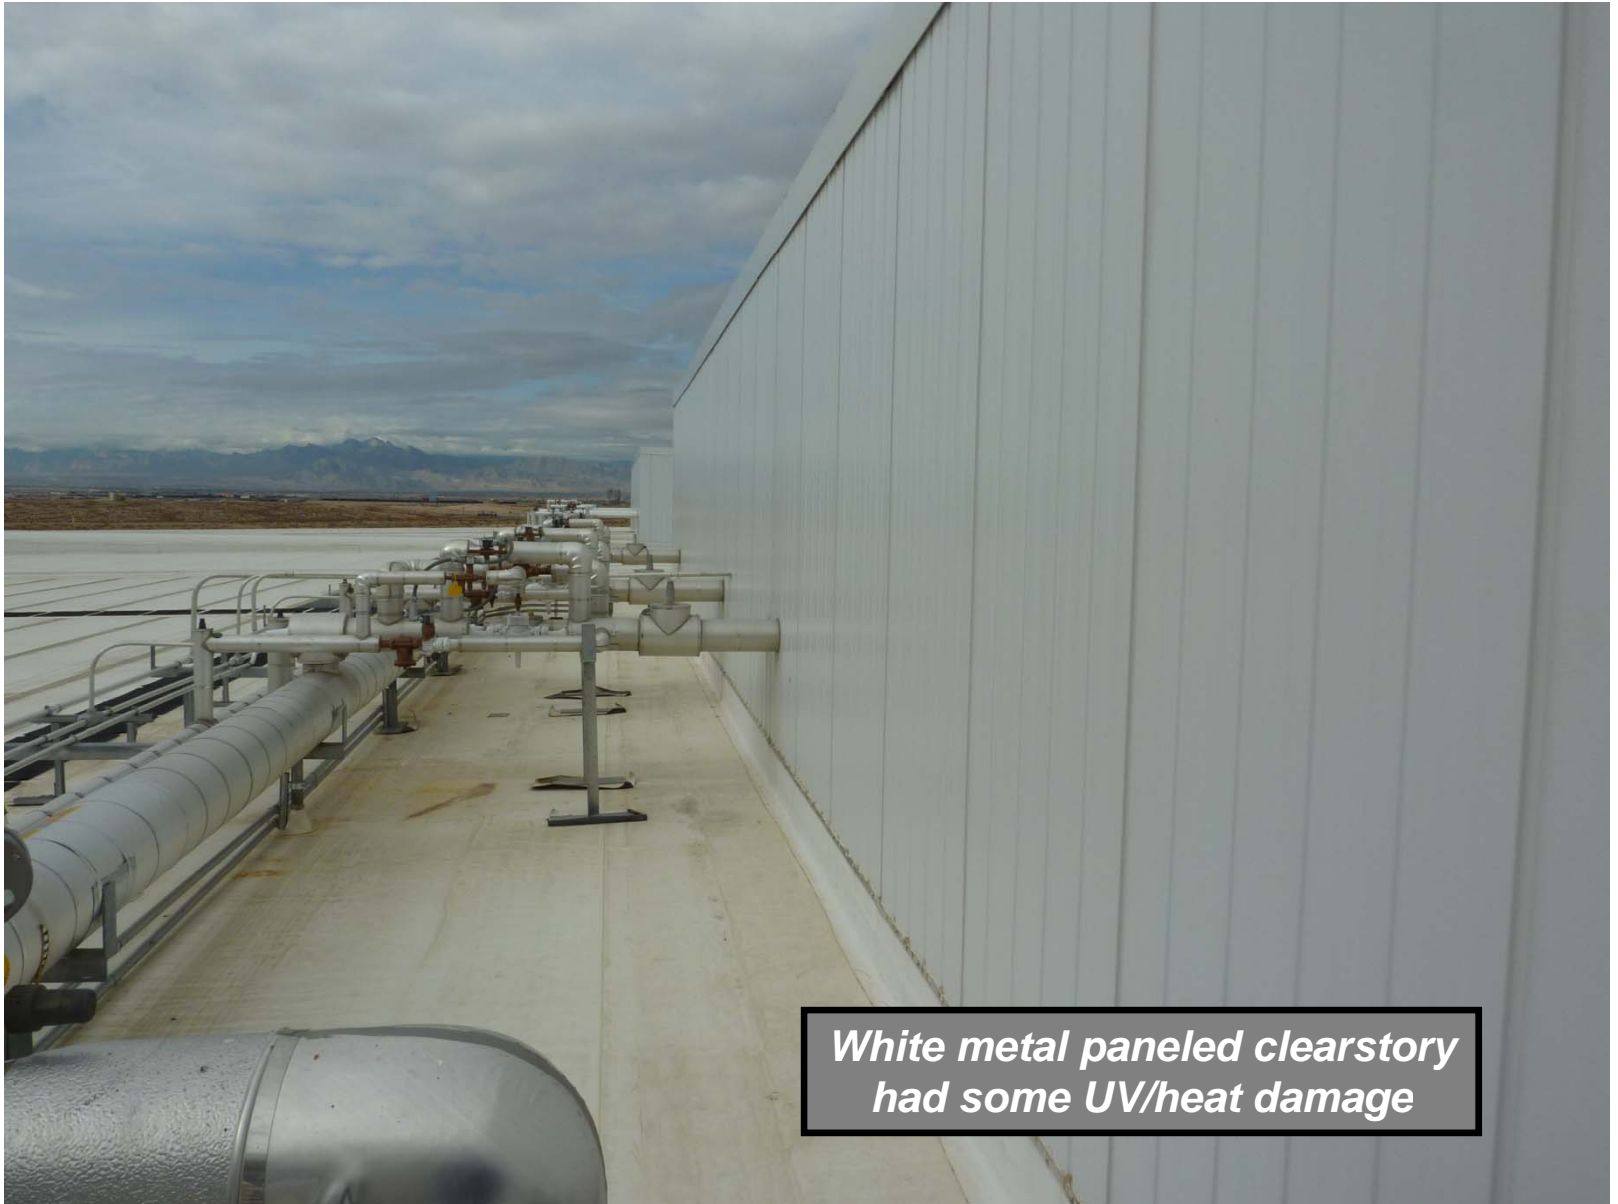
*White metal paneled clearstory
had some UV/heat damage*

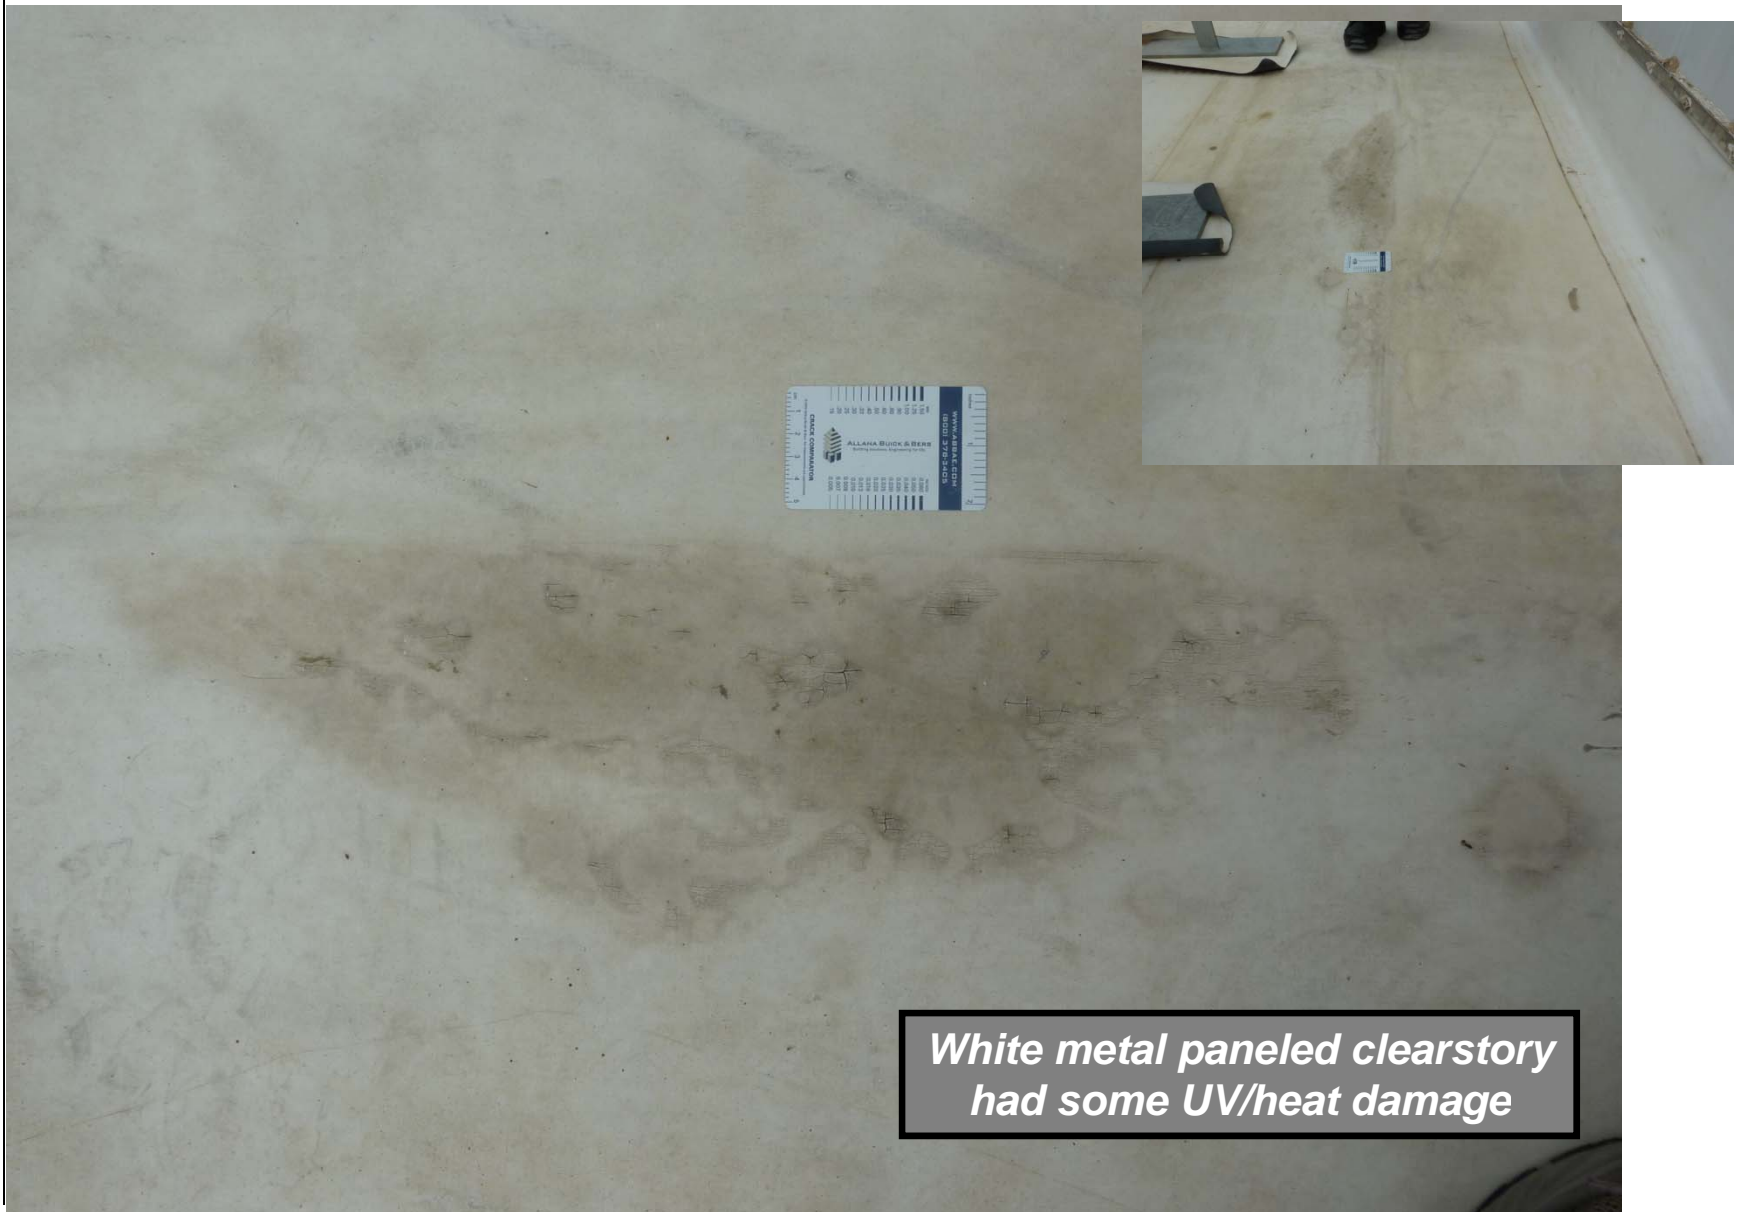
White metal paneled clearstory had some UV/heat damage
