**Critical Review of the Life Span of
TPO and PVC
RCI Hawaii Seminar
January 20-21, 2010**

**Karim P. Allana, P.E., RRC, RWC
Allana Buick & Bers, Inc.**

Case Study: PVC

Case Study: TPO

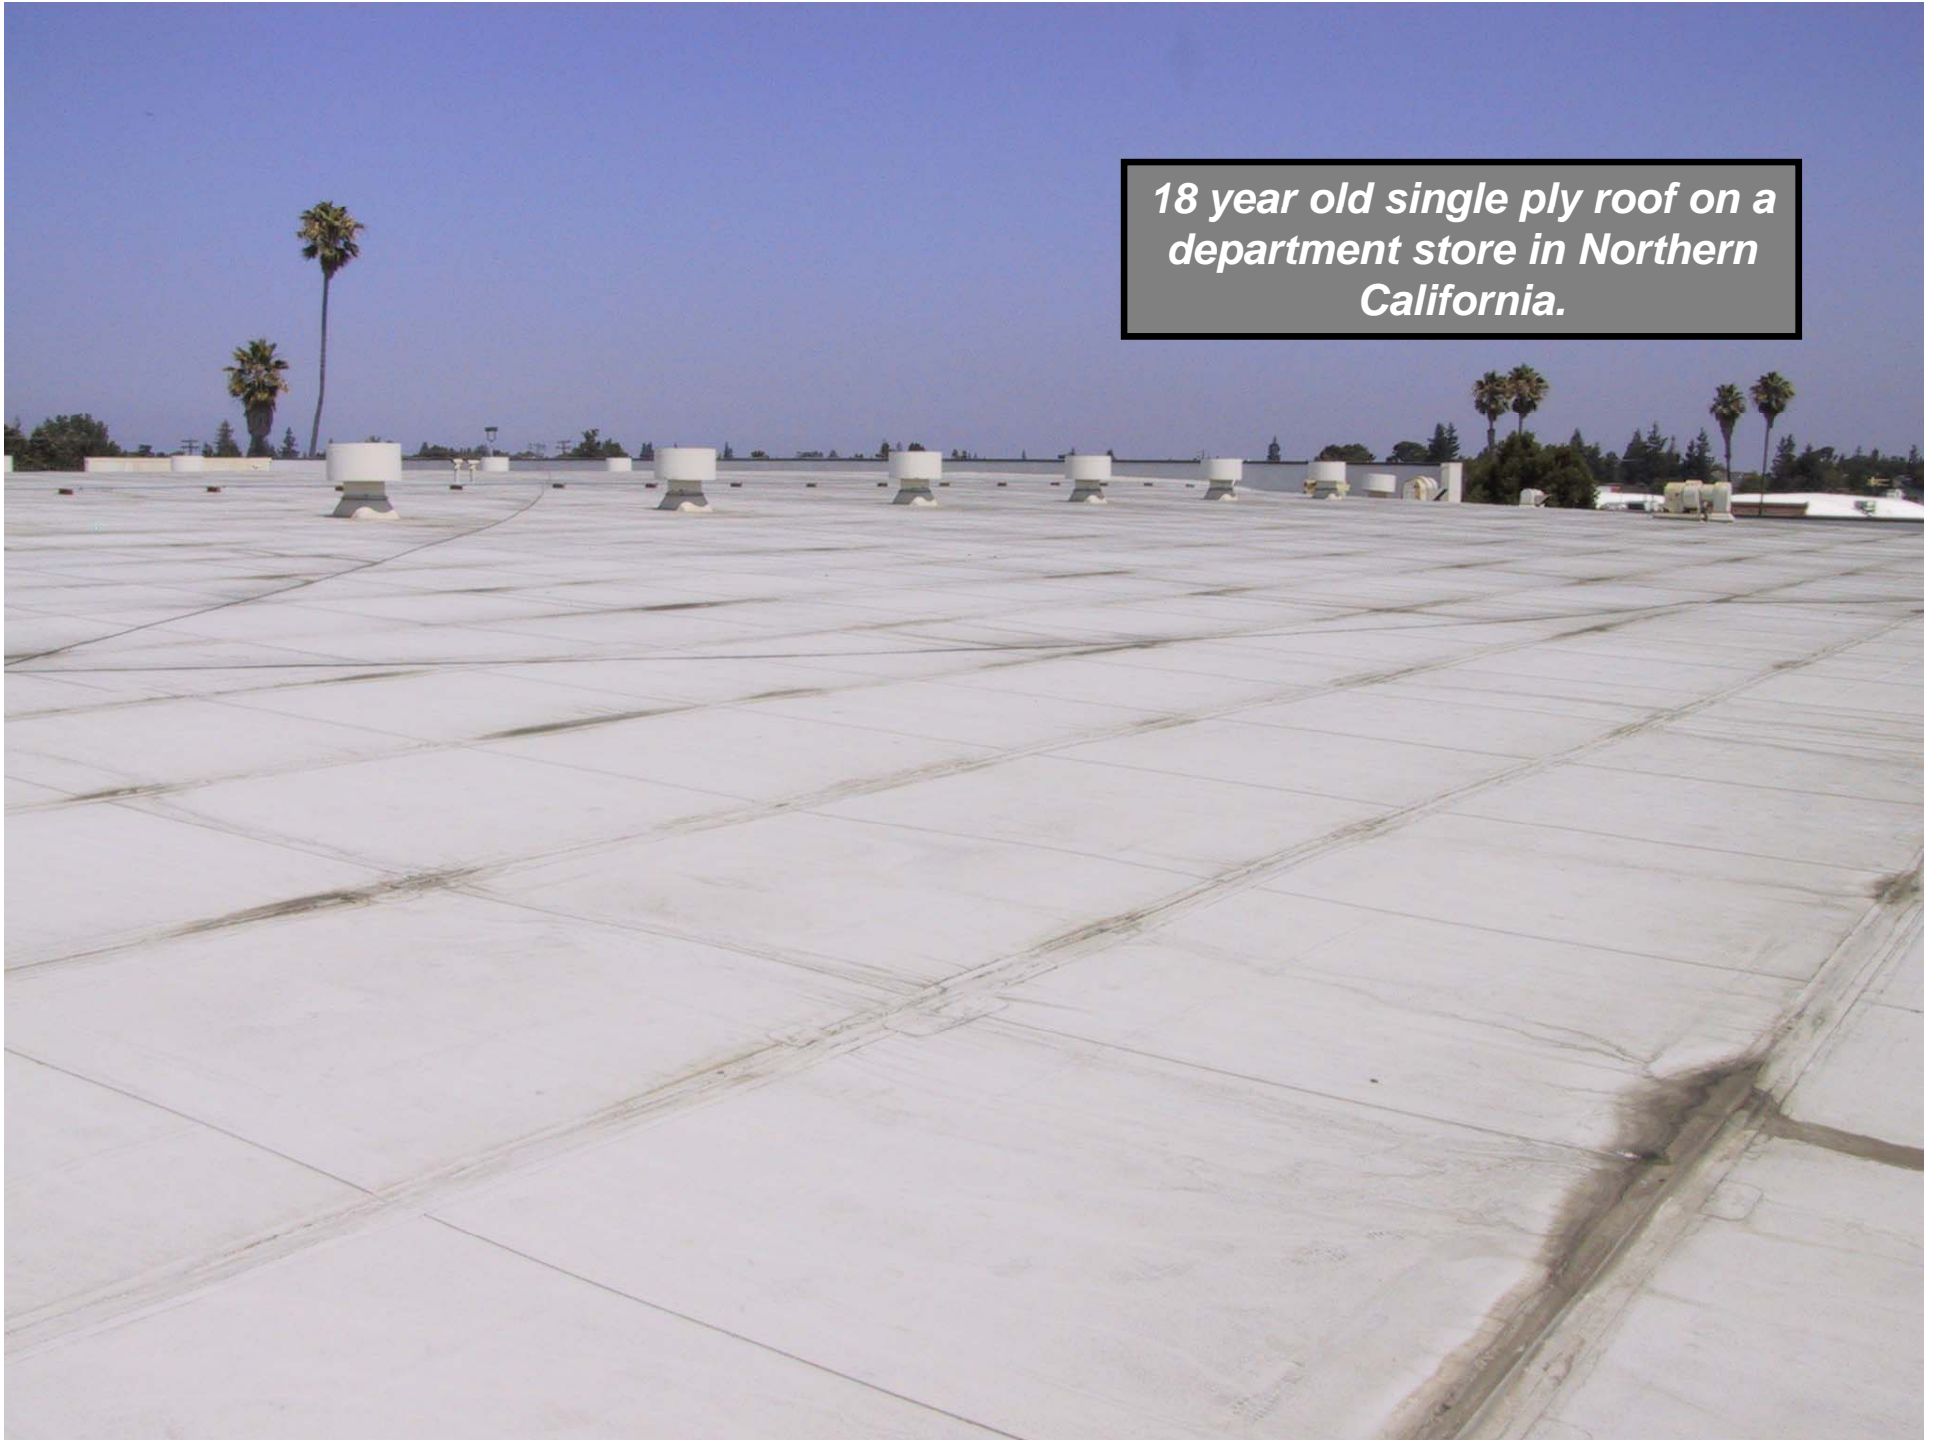
18 year old single ply roof on a department store in Northern California.

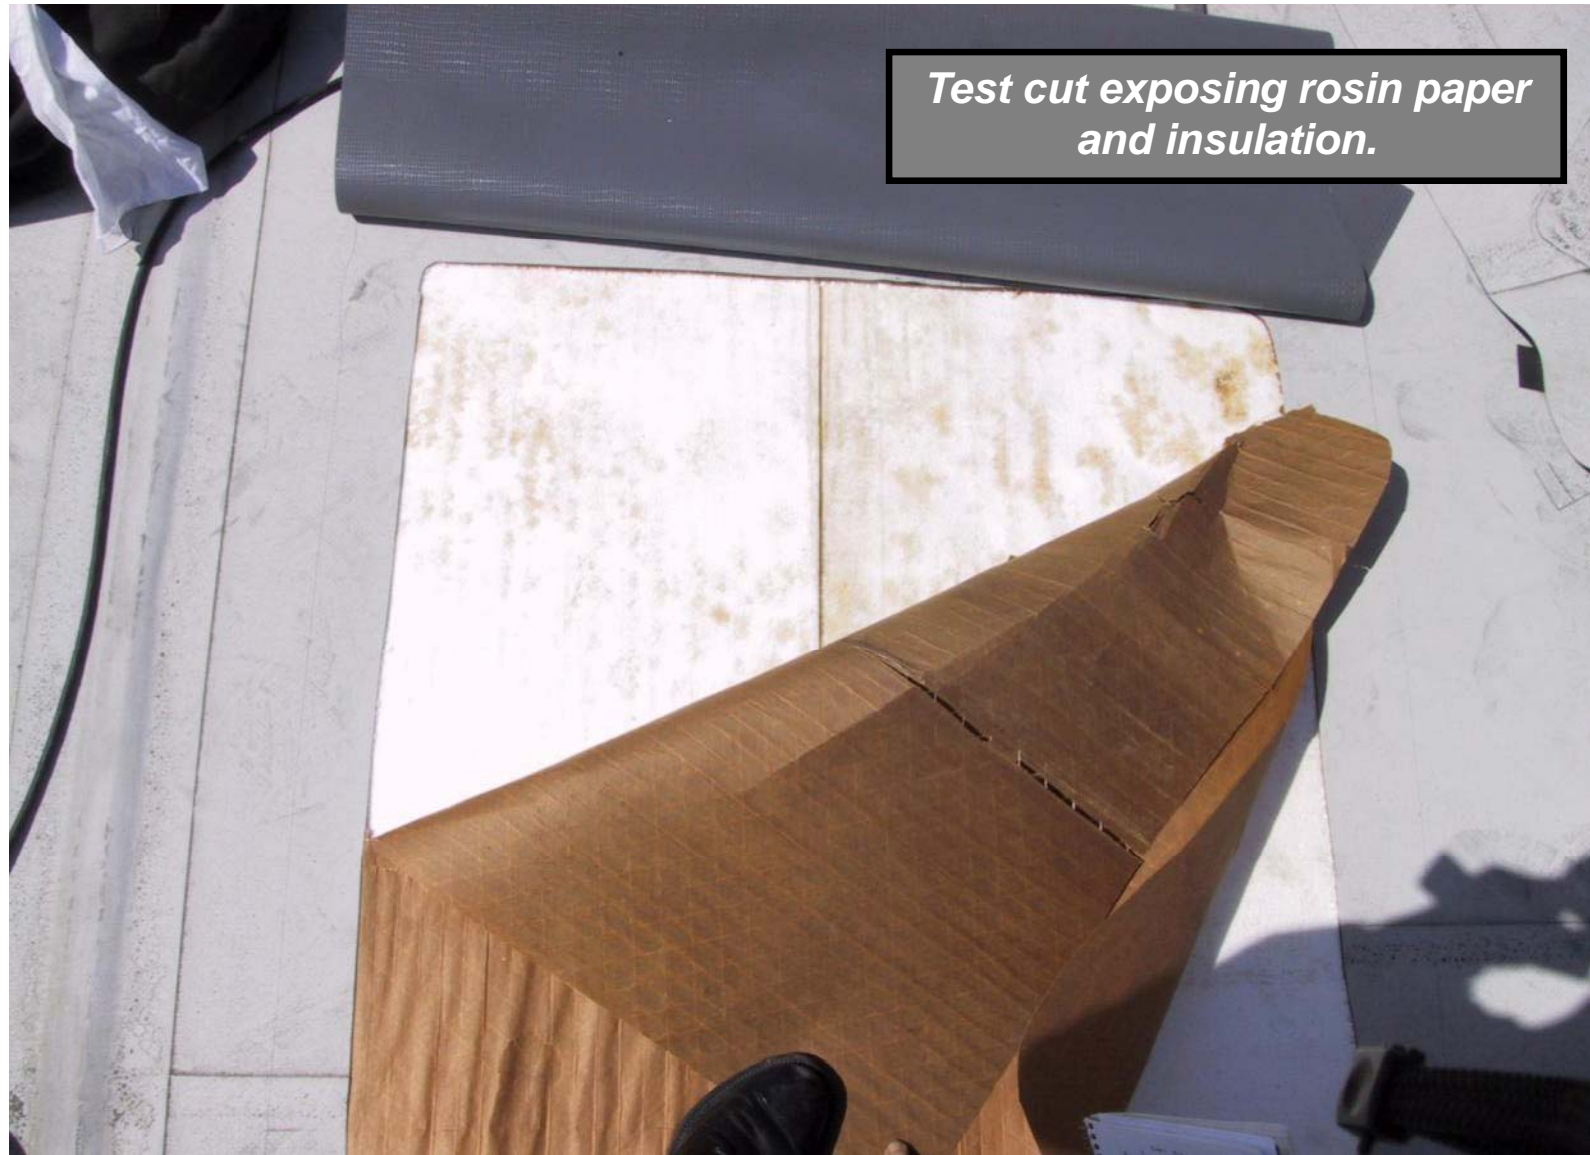
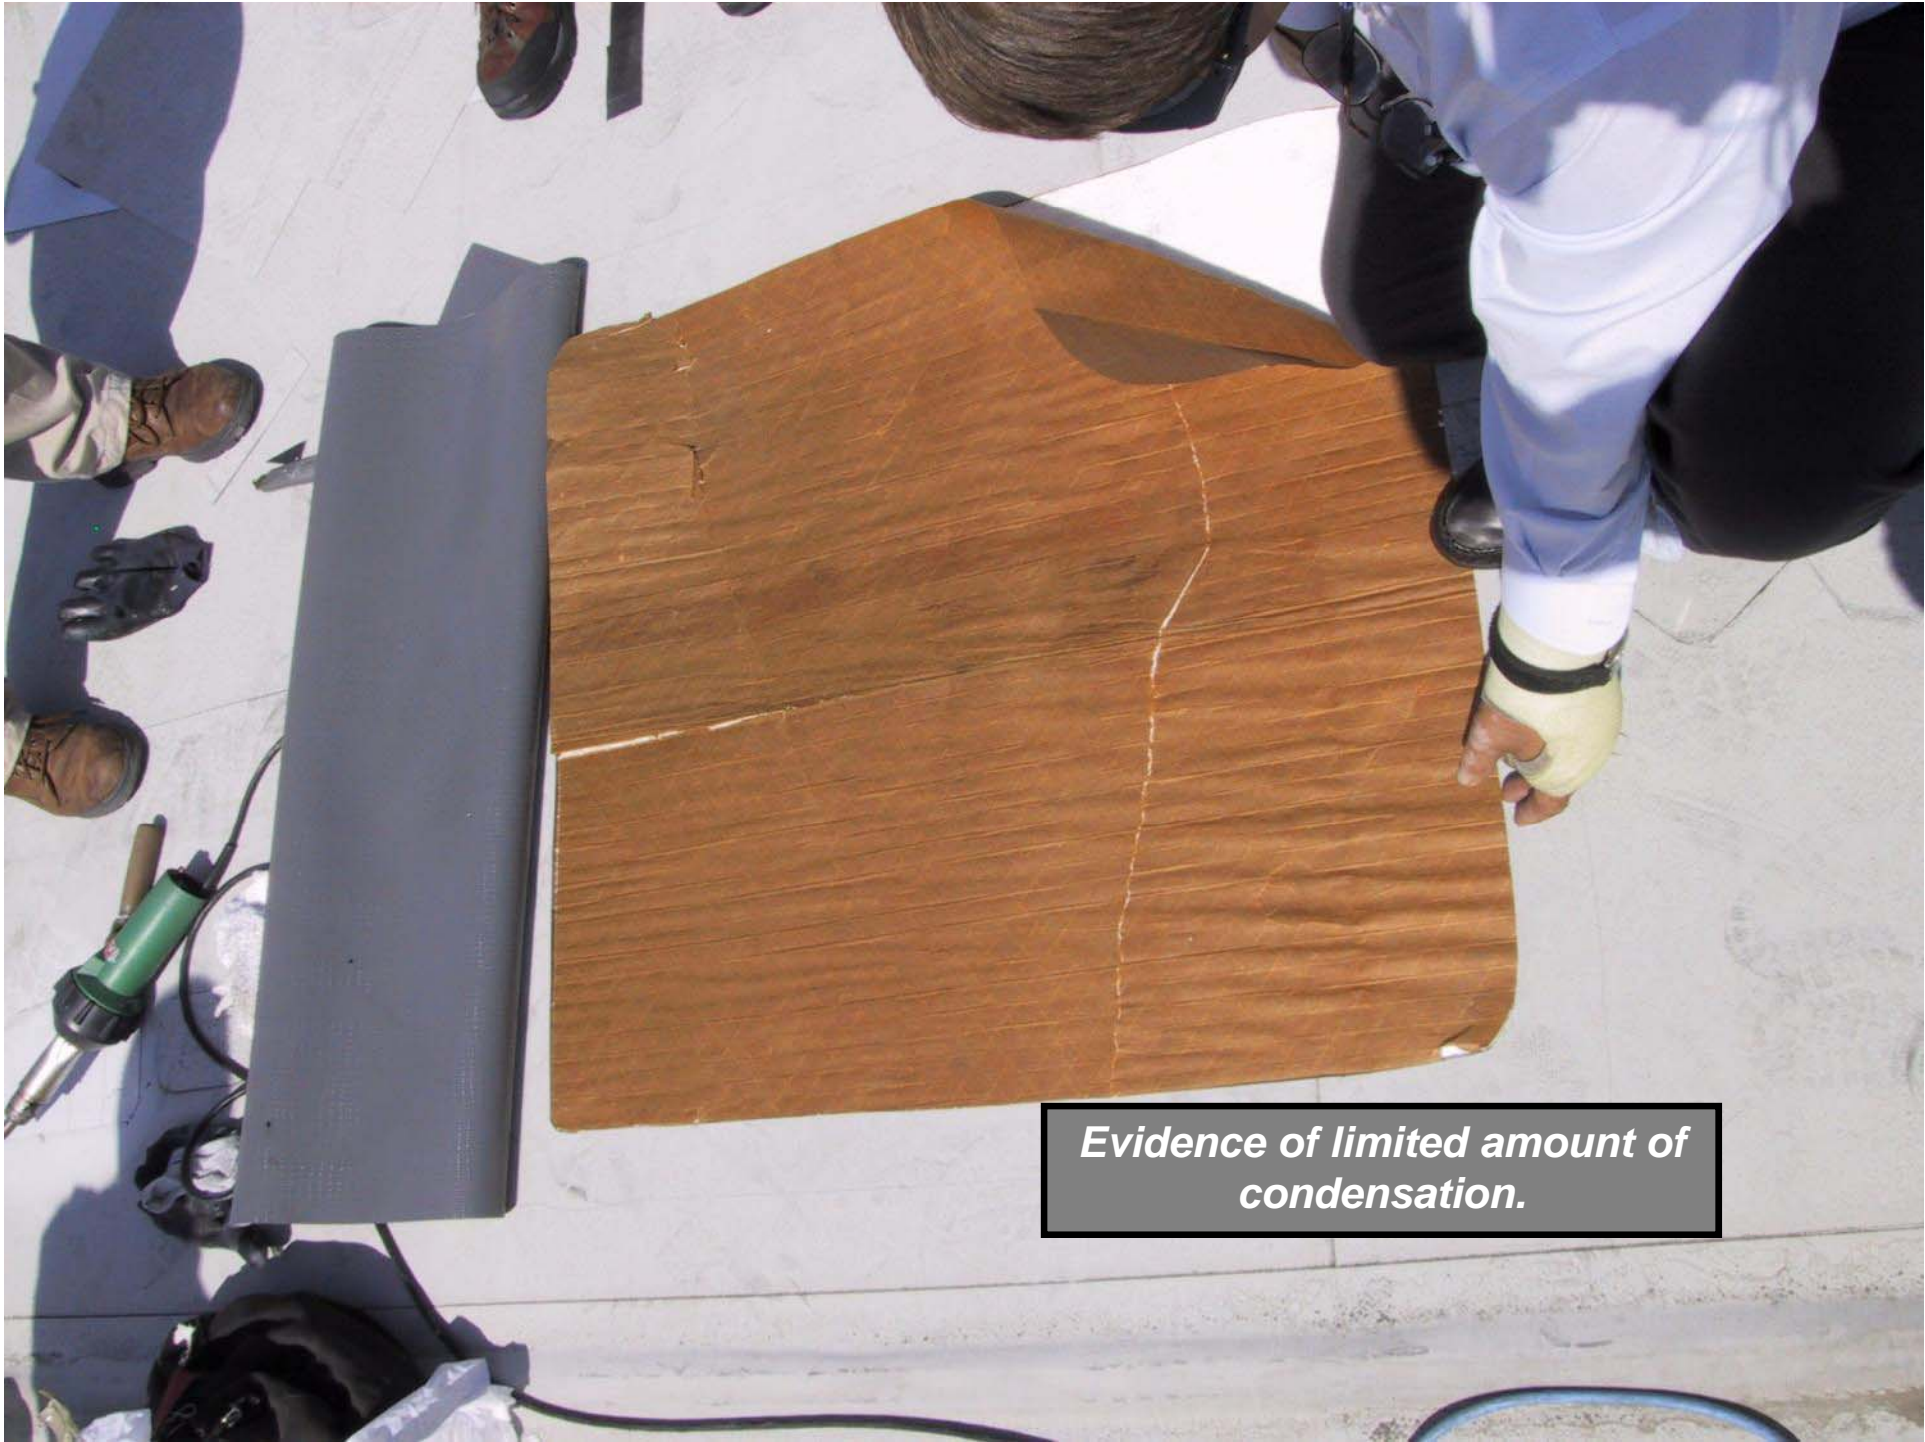
Test Cut Analysis

Evidence of limited amount of condensation.

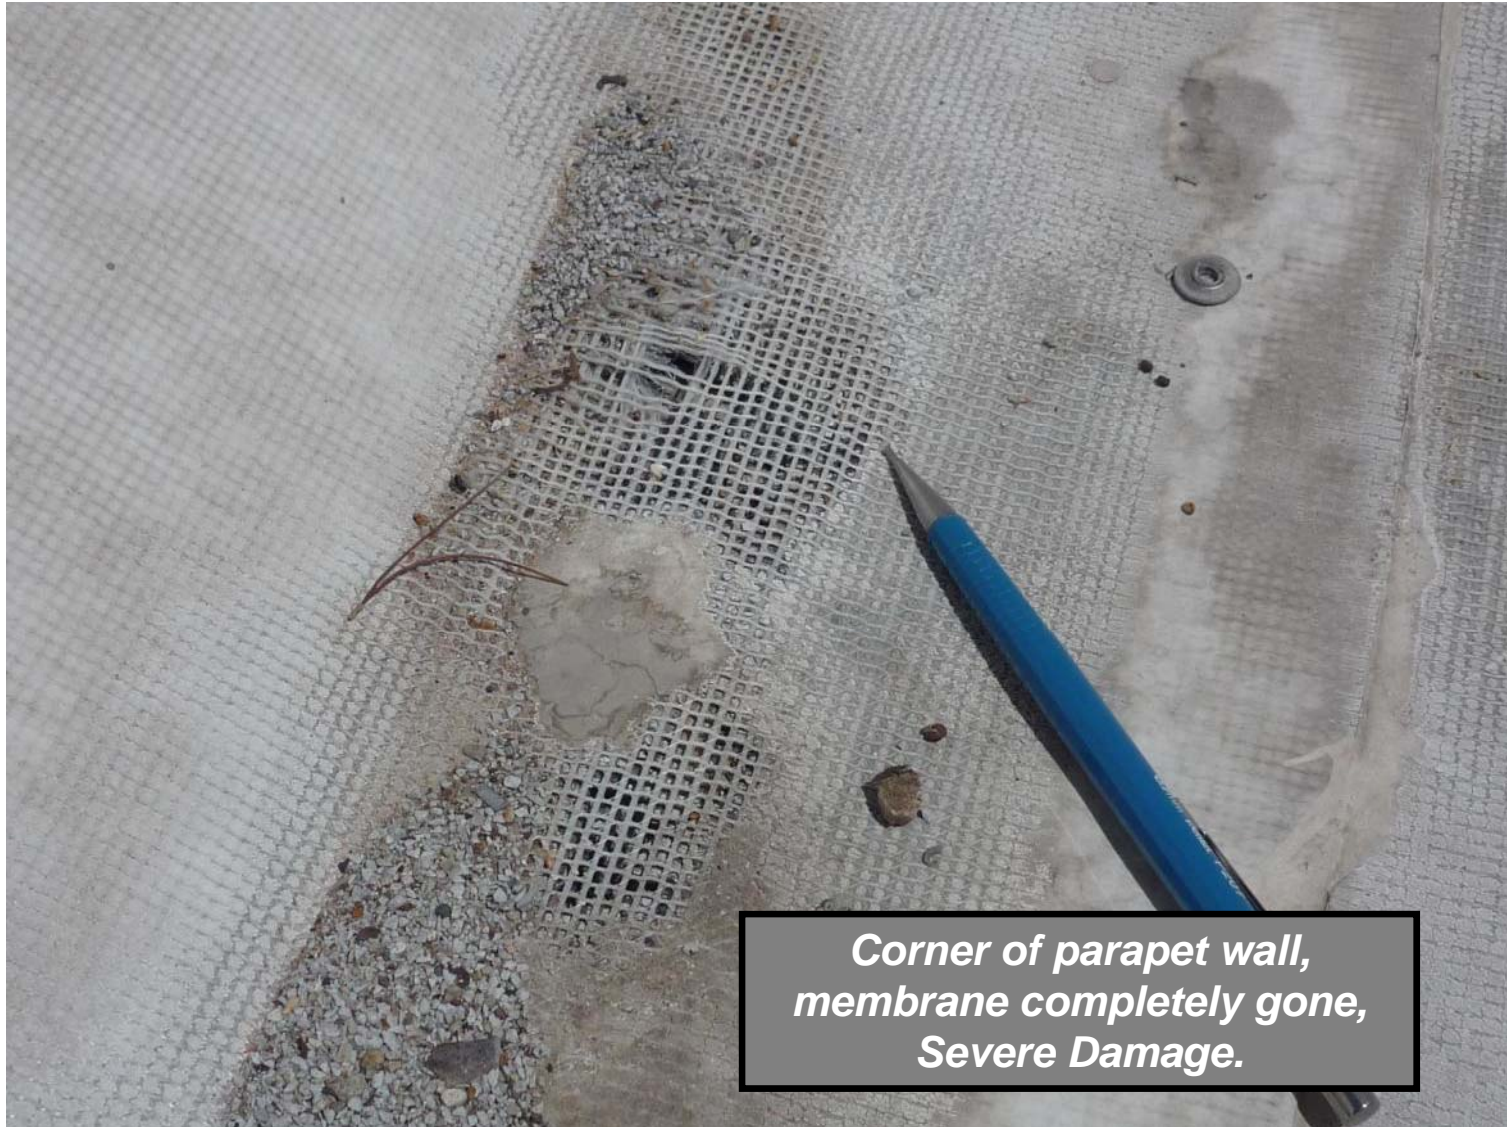
5 Years Old Carlisle, Hospital Building, Vegas

*Next to parapet wall,
membrane severe damage.*

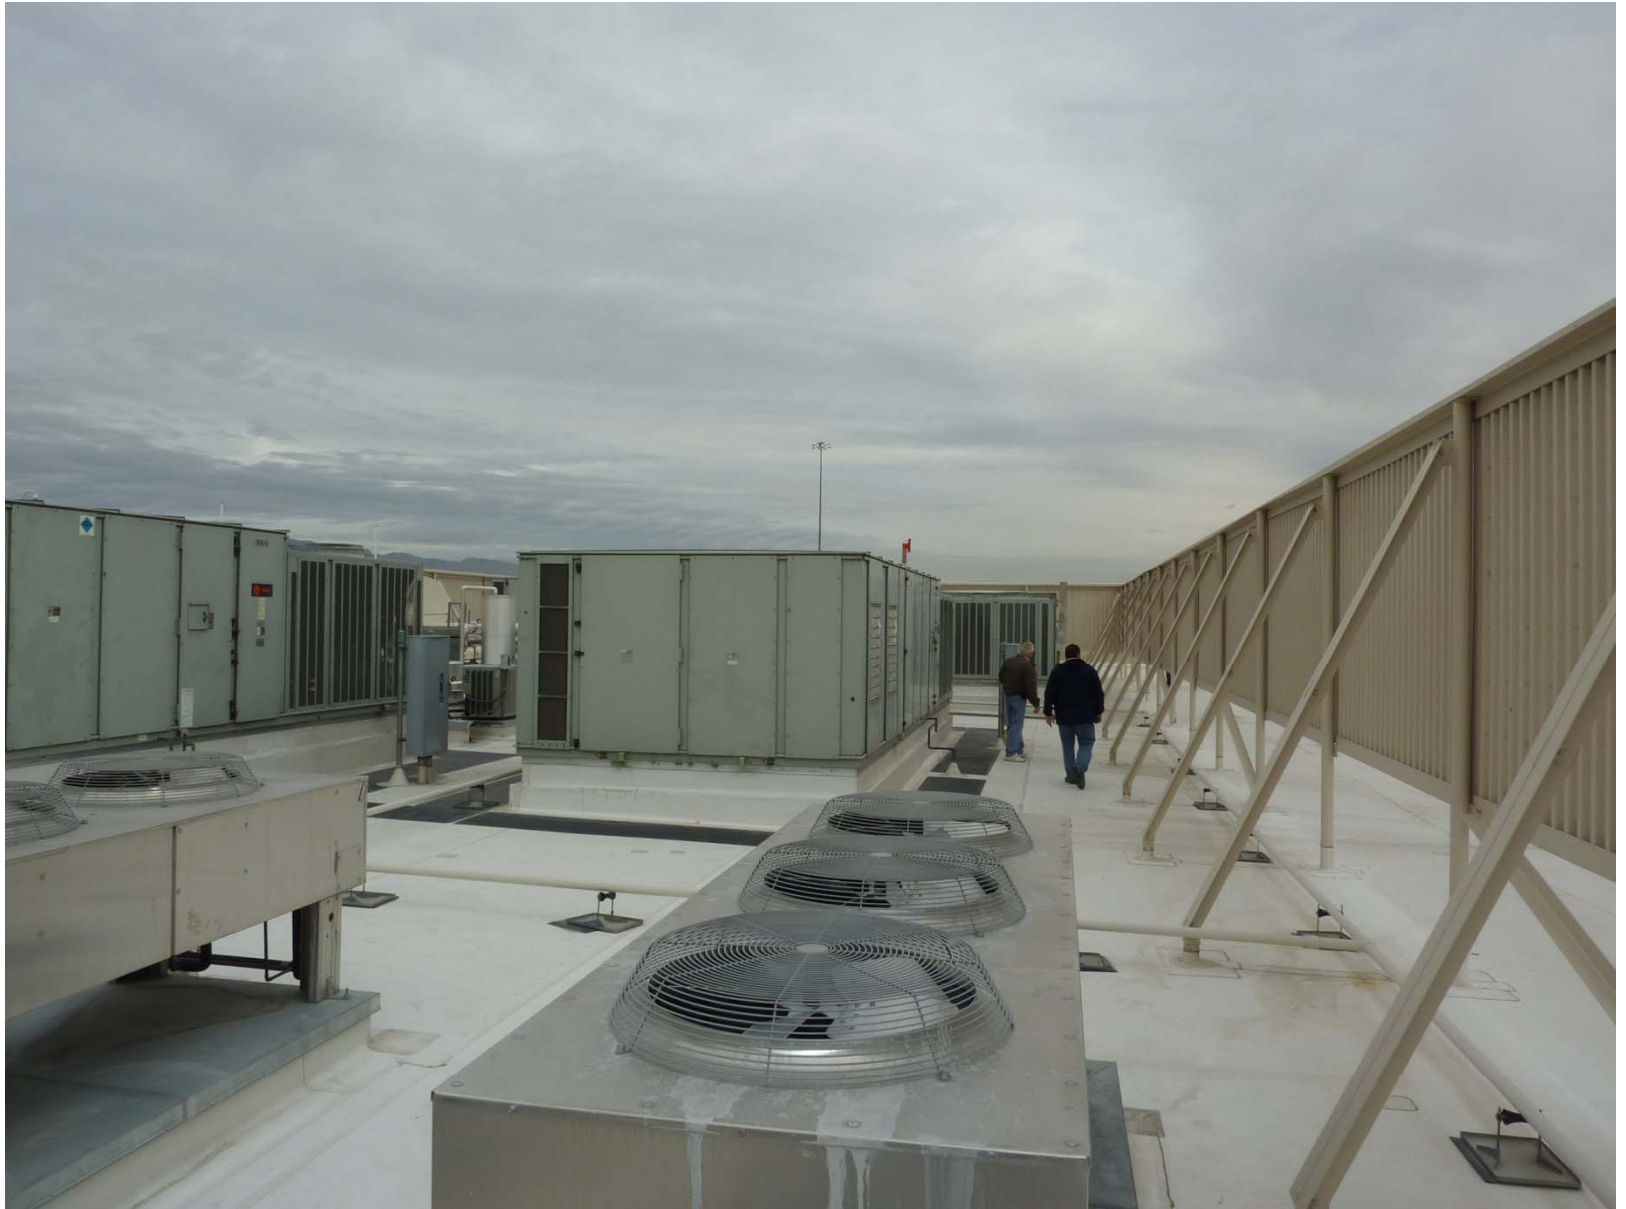
5 Years Old, Firestone 40 Mil, Molasky Bldg.

*South side exposure, reflection
and walk pad, no significant
damage*

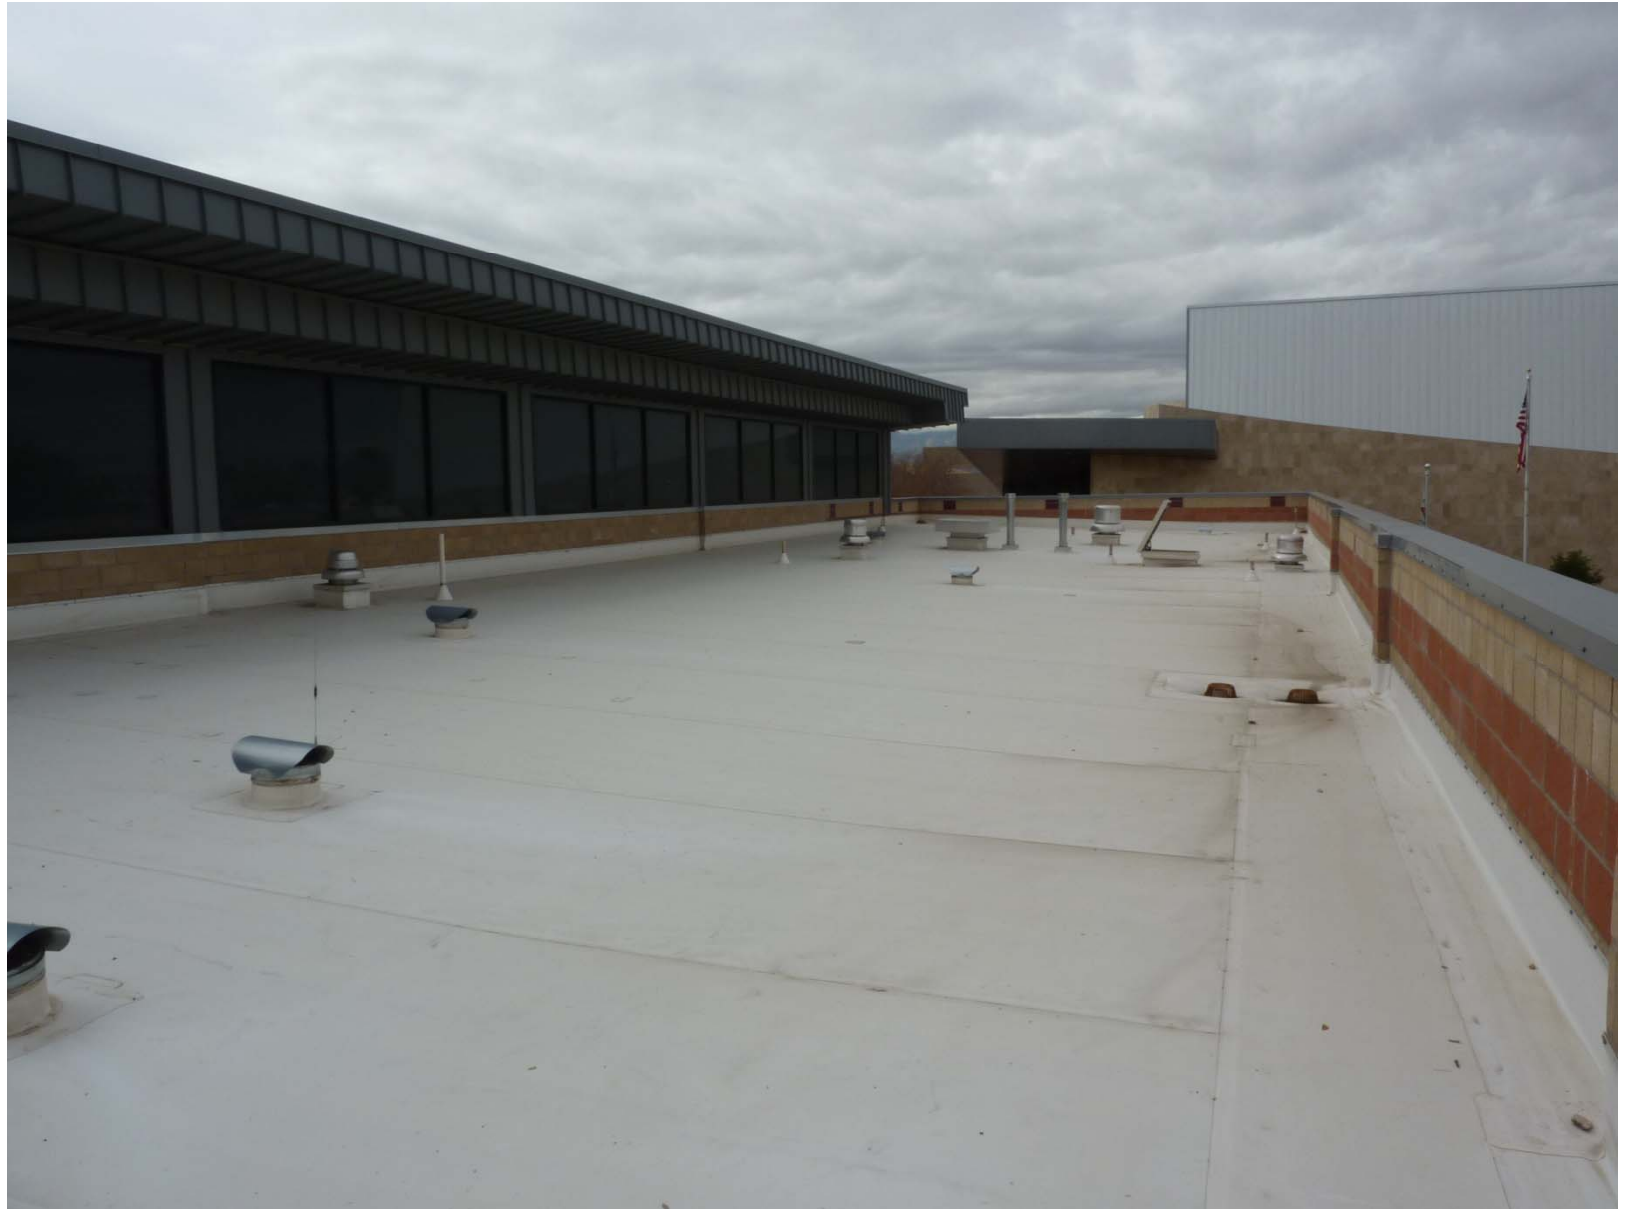
7 Years Old Firestone, Agasi College, Vegas

*Southern Exposure however,
no reflecting wall surfaces.
Observed no accelerated
deterioration.*

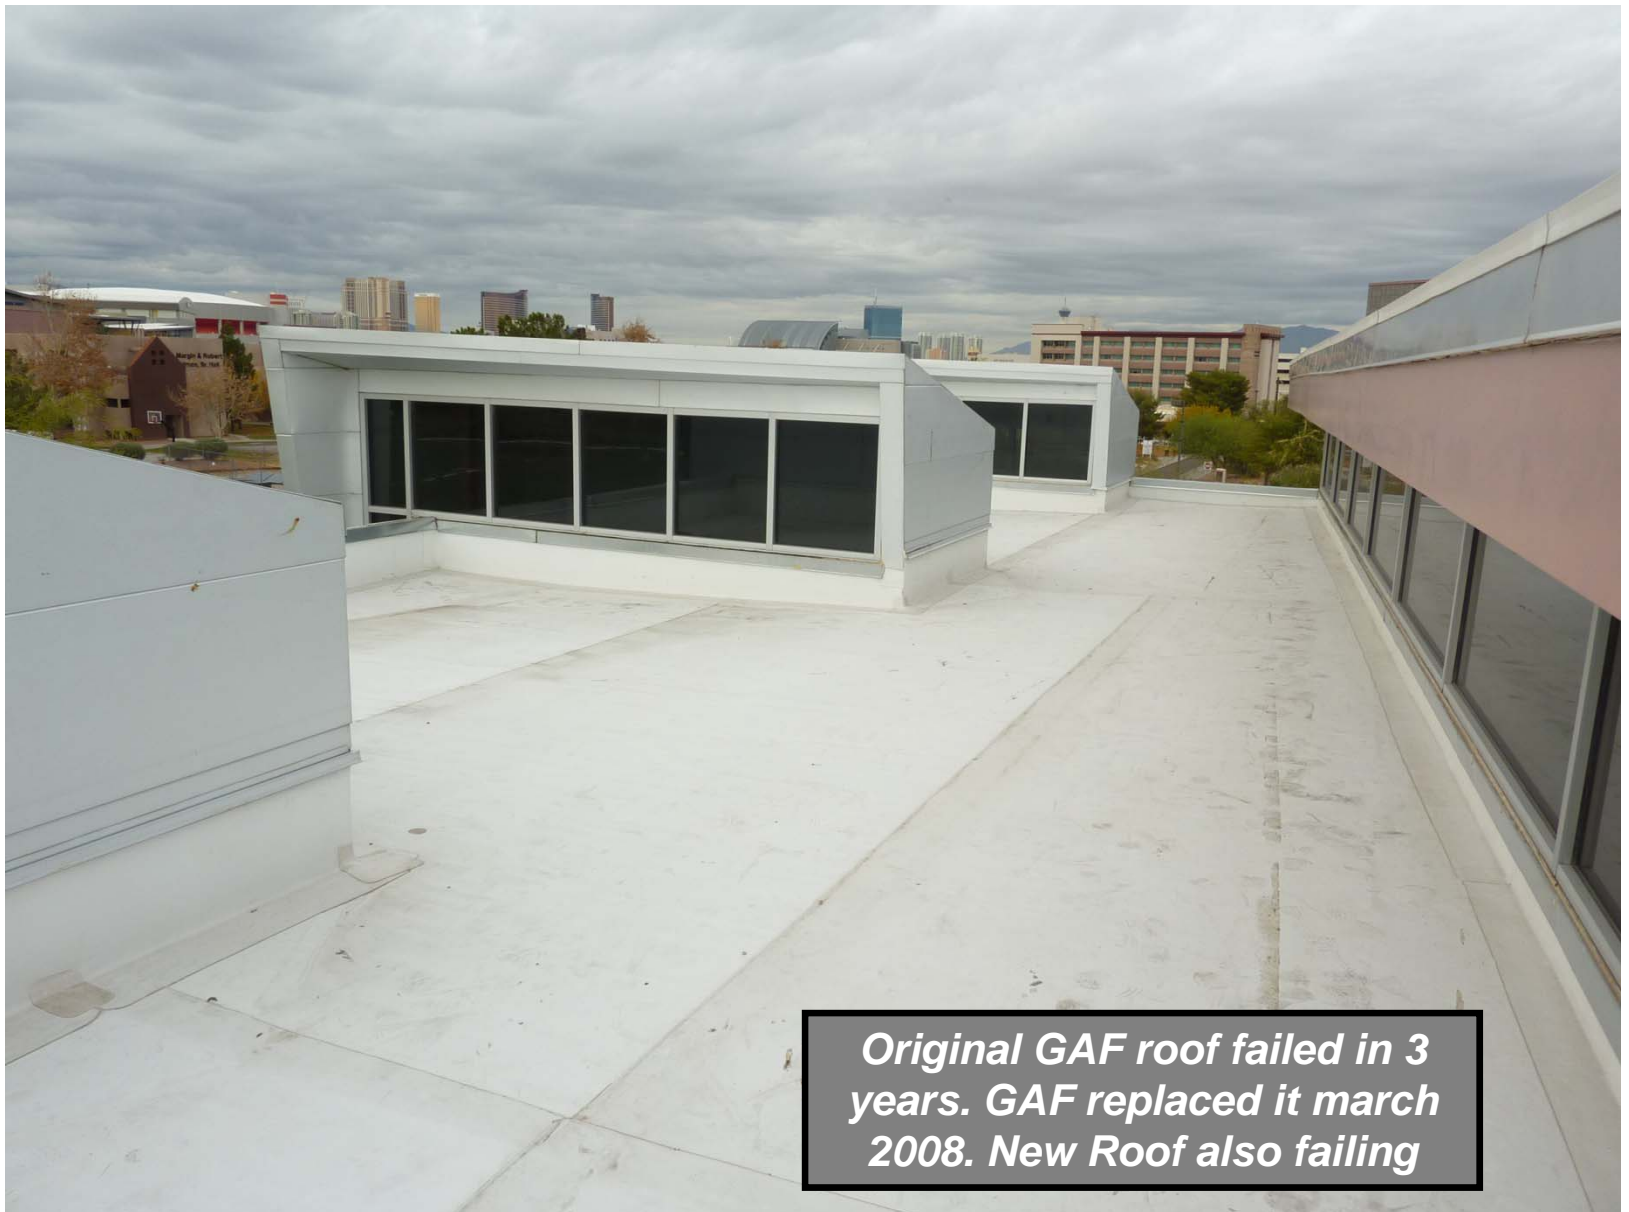
UNLV, ARC Building, GAF TPO 2.5 years old

This replacement GAF roof is less than 3 years old!

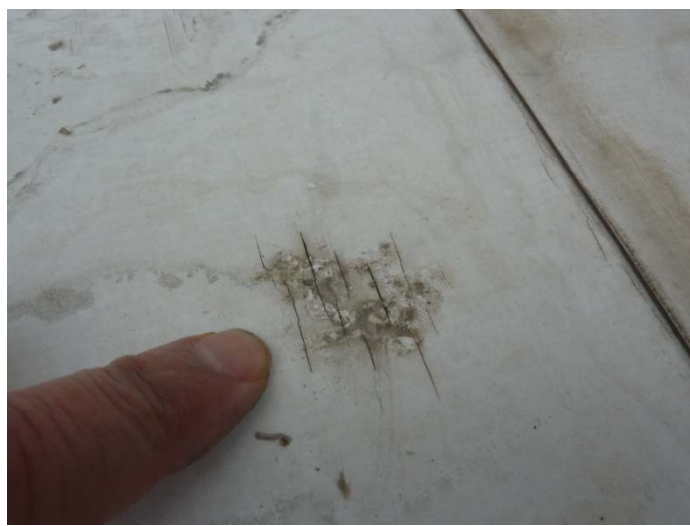
UNLV Bookstore, Firestone 11 Years Old

Roof has south facing stucco parapet. No heat related failures were observed

While there were no heat related failures, all attempts to heat weld/patch the roof were unsuccessful.

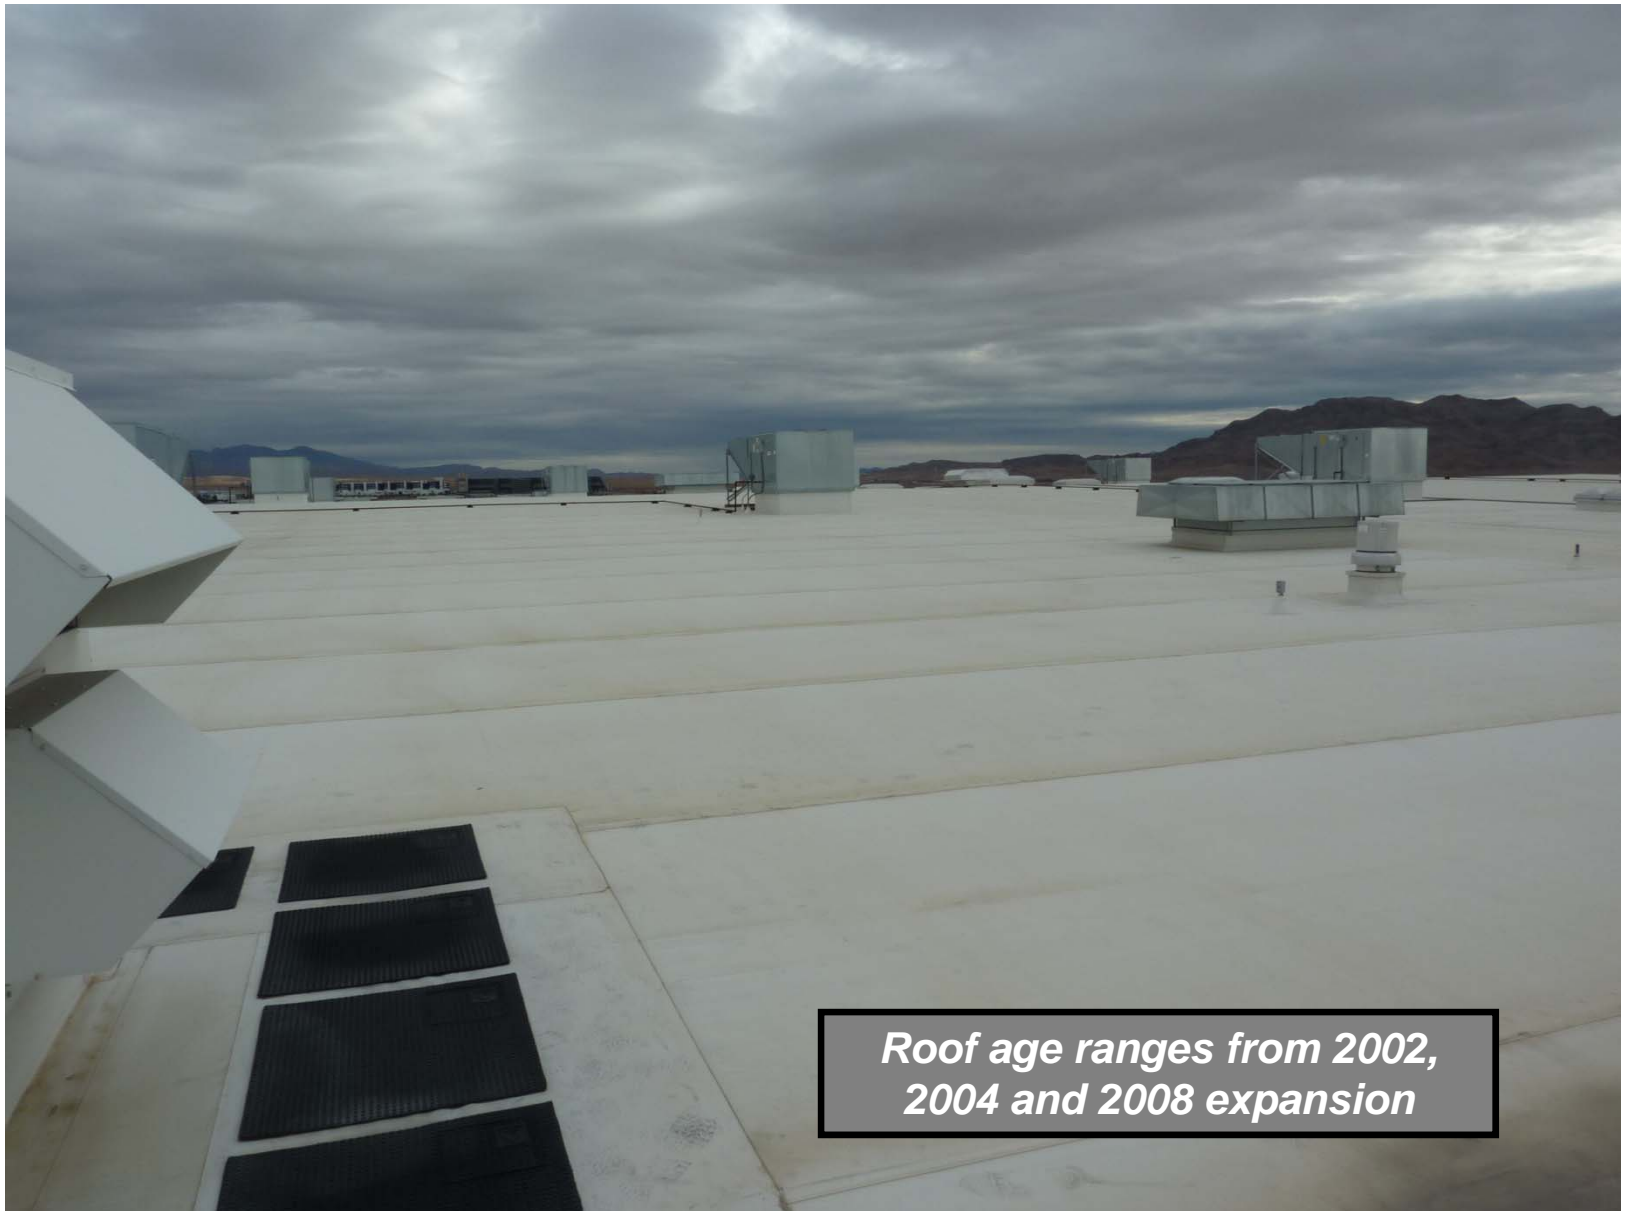
Sysco, Las Vegas, Firestone 8 Years Old

*Roof age ranges from 2002,
2004 and 2008 expansion*
